Report of Findings

Assessment for Fungi at a Municipal Building
6130 Sunset Drive
South Miami, Florida 33143
File Number: 11-11-0803-M

The City of South Miami

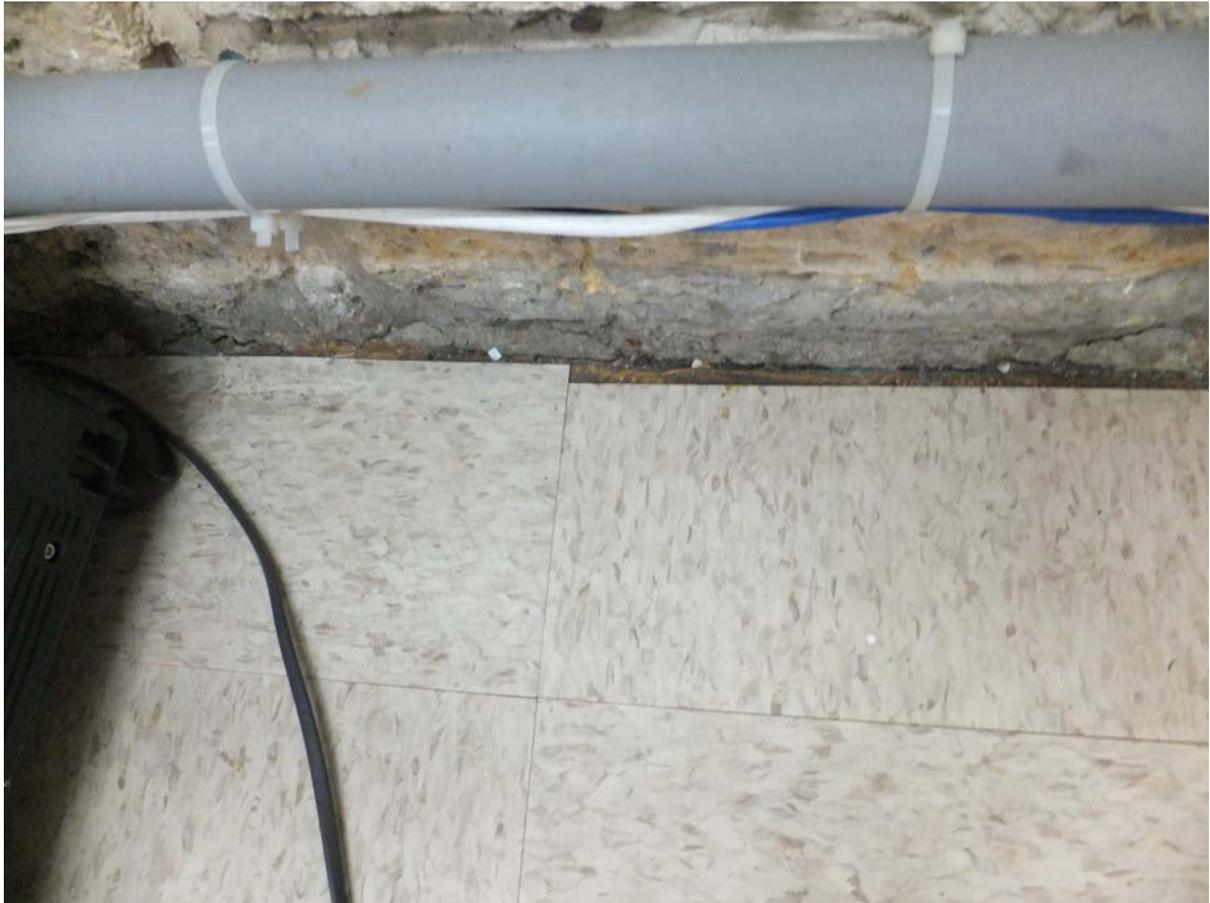
- There is visible water damage and water stains along the wall bottoms in the Central Services Building. There is continued elevated moisture beneath the tile floor covering in the front fingerprint area of this building. There are openings at the edge of the tile floor covering and the adjoining wall that allows water intrusion beneath the tile floor covering. The tile floor covering should be removed under containment and disposed of. The slab should be abrasively cleaned to remove any remaining mastic and then re-sealed prior to the installation of any new floor covering.

Location	WD	FG	EM	Description	Photo #
Front Fingerprint Area	√		√	Separation at wall edge allows water to intrude beneath floor tile and remain captured there.	3

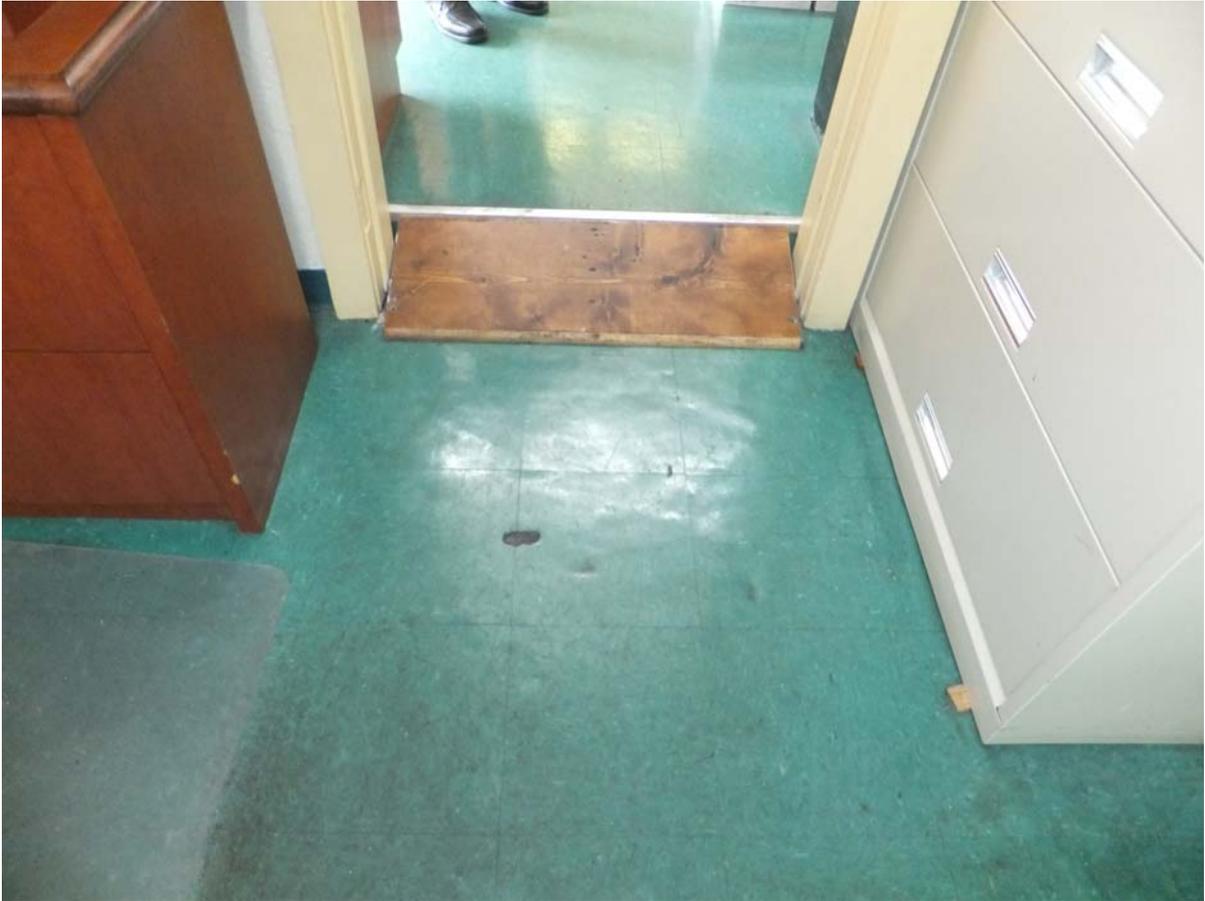
- There is elevated moisture beneath the green tile floor covering in the Middle Room with the copy equipment. The elevated moisture ceases and is not present beneath the floor covering in the back office that is elevated by a step up. There is a distinct possibility that the green tile and mastic used beneath it contain asbestos. As such, this tile should be removed under the proper containment under negative air pressure, with appropriate HEPA filtration in place within the containment and disposed of in a legal manner pursuant to the statutes regulating asbestos. The slab should be abrasively cleaned to remove any remaining mastic and then re-sealed prior to the installation of any new floor covering.

Location	WD	FG	EM	Description	Photo #
Middle Room	√		√	Elevated moisture in Middle Copy area does not extend into back room that is elevated.	5
