May 11, 2015
EE&G Project No.: 2012-2335

**Subject: Indoor Air Quality Assessment
City of South Miami Municipal Complex
6130 Sunset Drive
South Miami, Florida 33143**

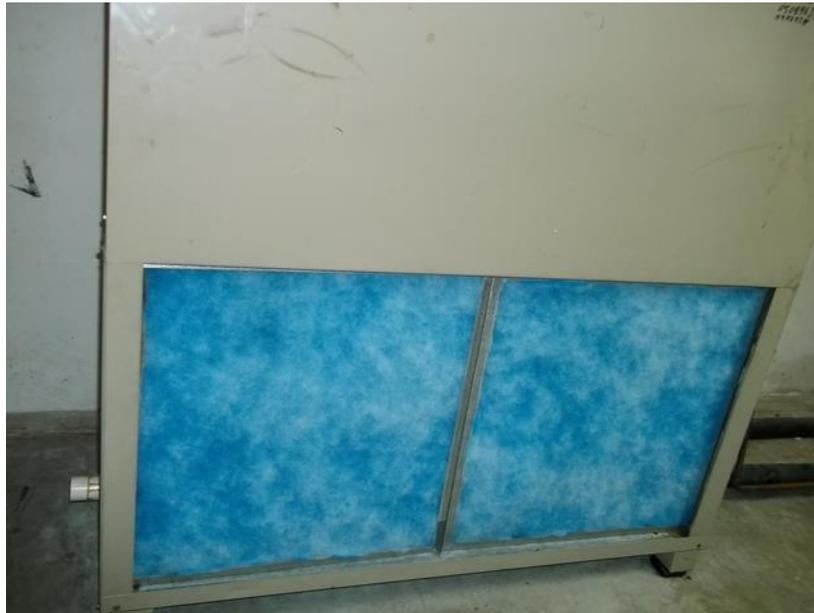
Photo 1: Typical air handler unit filter.

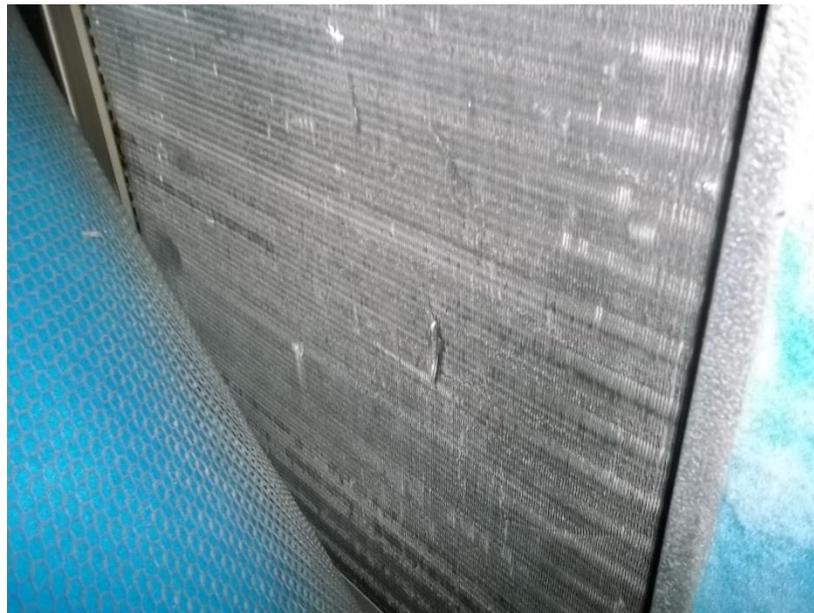
Photo 1: Typical air handler unit coils.

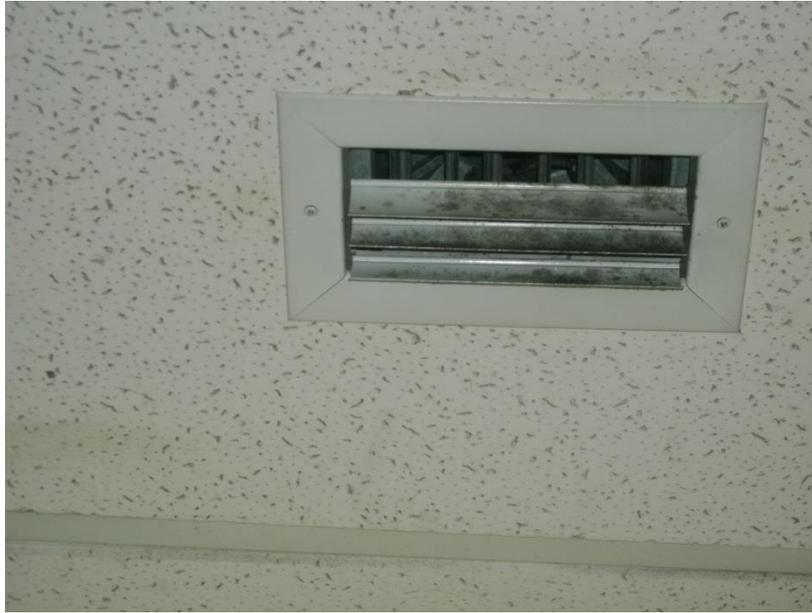
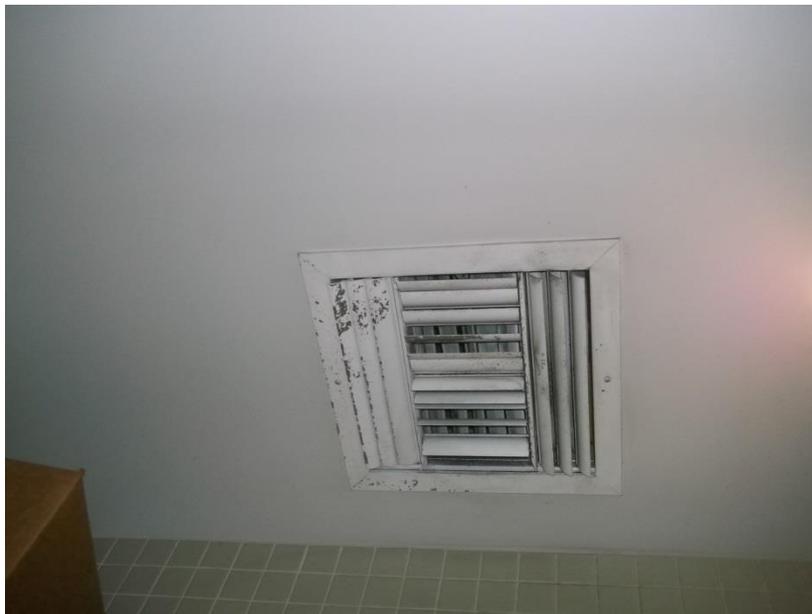
- There was dust, dirt, and debris (DDD) on the HVAC supply diffusers in various areas (see photos 3 and 4).
- The employees were utilizing heaters, fans, air purifiers, candles, plug-in insect repellants and traps. There were also plants in the office areas (see photos 5-8).
- There was a stained chair in the Commissioner's Office (see photo 9).
- Carpets were stained, dirty and generally worn (see photo 10).
- Supply vents were blocked/ covered in various areas (see photo 11).

Photo 3: DDD on the HVAC vents in various areas.

Photo 4: DDD on the HVAC vents in various areas.

- A qualified mechanical contractor should be retained to verify the volume of outside air into the HVAC system and conduct a balance test. The vents should be cleaned and consider cleaning HVAC return and supply vents monthly regardless of visual debris build-up.

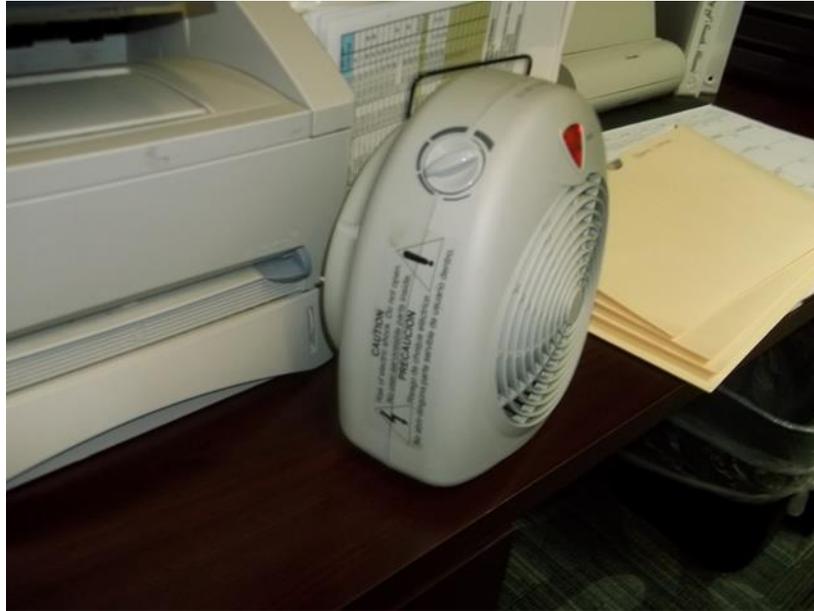
- The use of heaters, fans, air purifiers and blocked supply vents may indicate the employees' comfort levels vary within the building. This is maybe due to an unbalanced HVAC system. The overall condition and hygiene of the AHUs was good as evidenced by the visual findings of clean cooling coils and filters, and the lack of accumulation of condensate water (a likely source of biofilm). The control of outside air was not fully known and may require adjustment to ensure compliance with ASHRAE standards. The environmental parameter readings (relative humidity, temperature, and dew point) were within the current ASHRAE Standard citing acceptable thermal comfort guidelines for building occupants.

Photo 5: The employees were utilizing heaters.

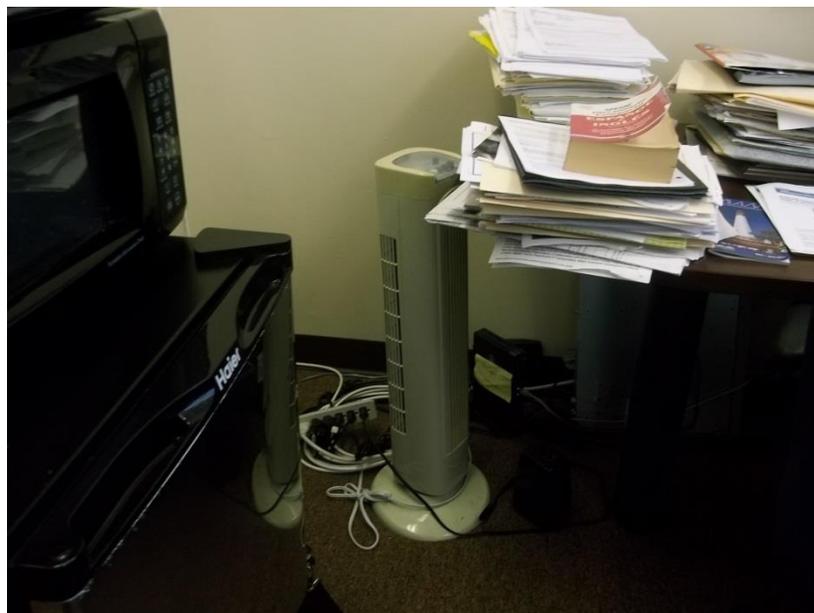
Photo 6: The employees were utilizing air purifiers.

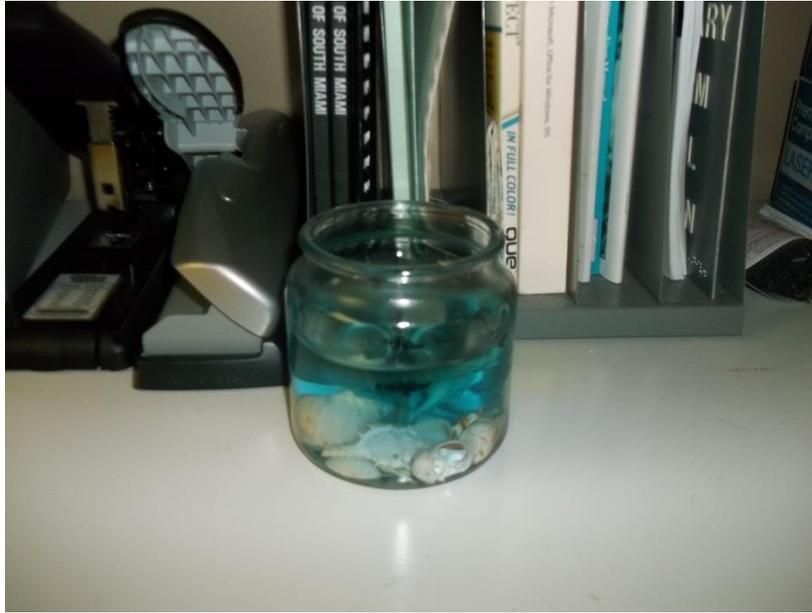
- The use of candles, insect traps and repellents attest to the observed mosquito problem. Mosquitos are not commonly considered an IAQ issue, however based upon the use of these products there appears to be an ongoing mosquito issue and this could be impacting work productivity. Also, as mentioned in the formaldehyde report associated with this IAQ assessment, candles can contribute to an IAQ problem and occupant complaints by emitting formaldehyde and other irritants including particulate matter, benzene, toluene, acetaldehyde and acrolein. Insecticides are often not designed for inside use and may be emitting irritating chemicals that contribute to poor IAQ.

Photo 7: The employees were utilizing candles.

- Address the mosquito issue and look at removing candles, insecticides and live potted plants, which can contribute to an IAQ problem and occupant complaints.

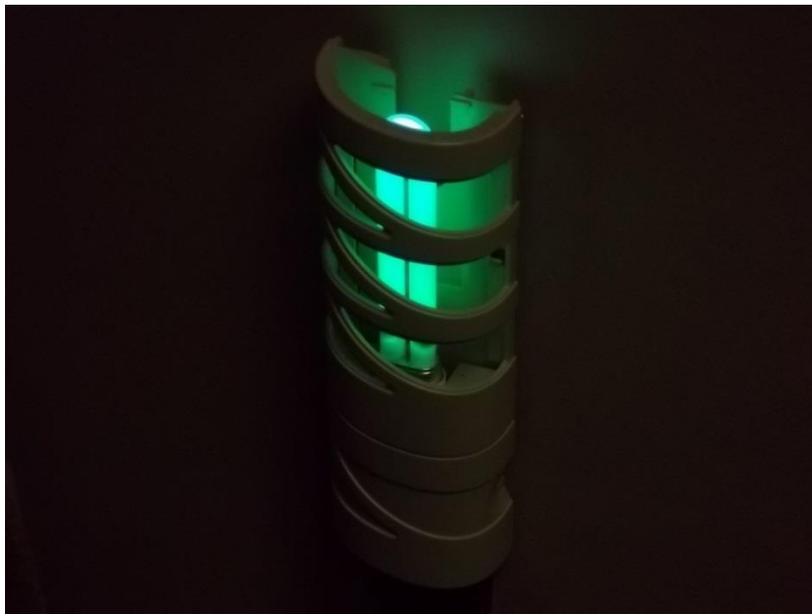
Photo 8: The employees were utilizing insect repellants and traps.

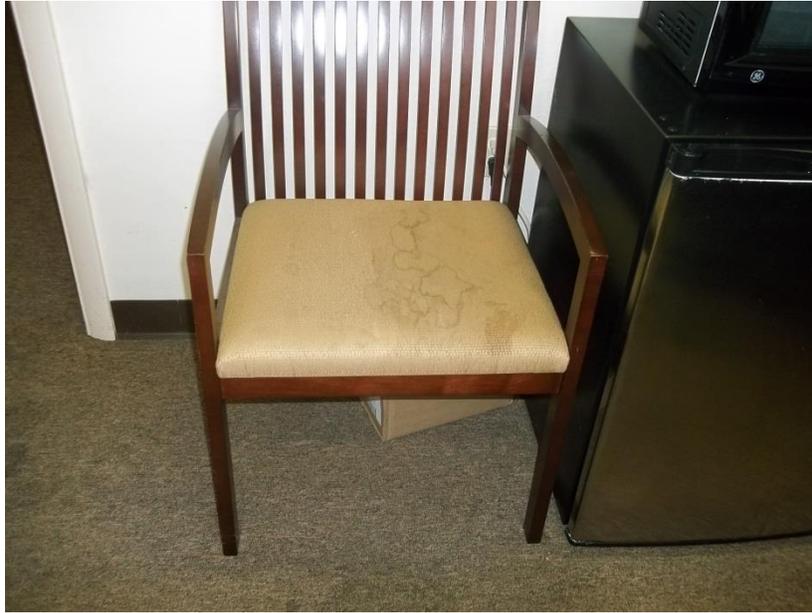
Photo 9: Stained chair in the Commissioner's Office.

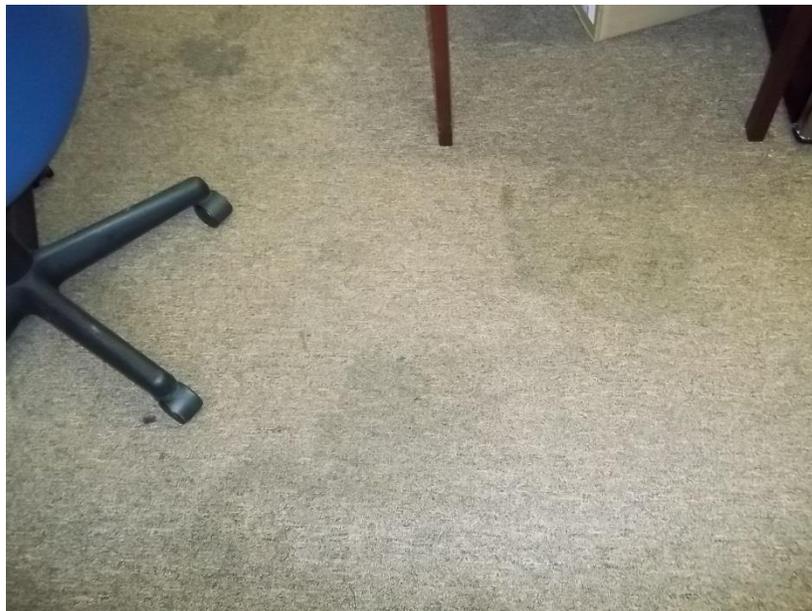
- Other possible sources of poor IAQ identified were the potted plants and dirty carpets. Both can cause allergies in susceptible occupants.

Photo 10: Carpets were stained, dirty and generally worn.

- Consider cleaning or replacing the carpets. Vinyl tile is highly recommended for commercial buildings to reduce dust and allergens.
- The above recommendations should improve the overall air quality and reduce occupant complaints. A follow up assessment after the recommendations are competed should be conducted to evaluate the effectiveness of the recommendations.

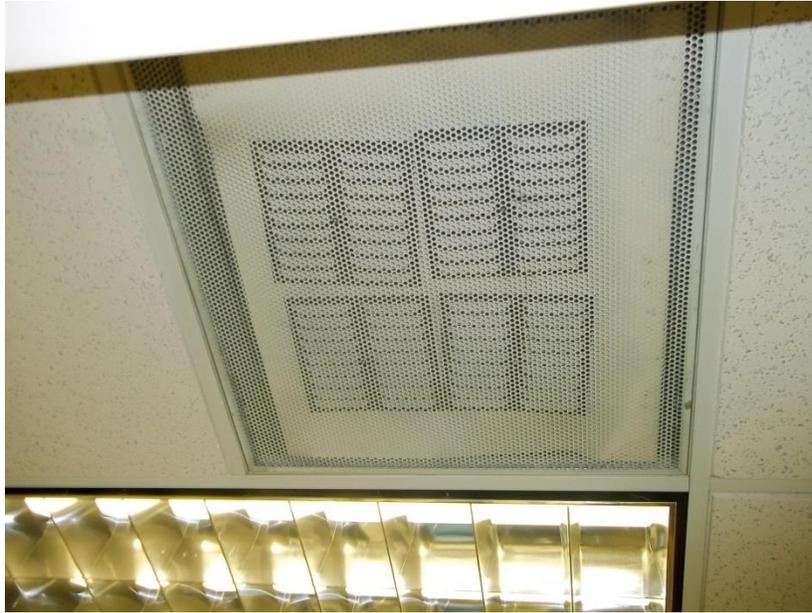
Photo 11: Supply vents were blocked/ covered in various areas.

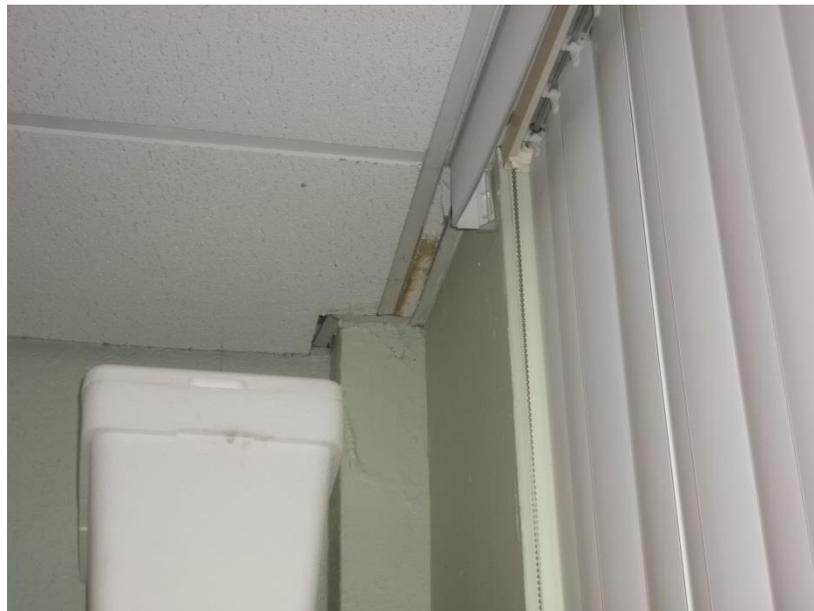
- Stained ceiling tiles were observed in the following areas of the first floor:
 - Lunch Room (see photo 12)
 - Water fountain (first floor corridor) (see photo 13)
 - Conference room in City Manager's offices
- Stained ceiling tiles were observed in the following areas of the second floor:
 - Mezzanine (see photo 14)
 - Kitchenette (see photo 15)
 - Computer Room (see photo 16)
- There was damage to the plaster wall and a stained window sill in the City Manager's Office (see photos 17 and 18).
- There appeared to be a past water intrusion event on the landing on the stairs identified by stained carpet and water stained wall (see photo 19).
- There was water staining to the plaster ceiling in the second floor storage closet (see photo 20).
- Mosquitos were observed inside the building.

Photo 12: Stained ceiling tiles were observed in the Lunch Room.

- Replace stained ceiling tiles and repair areas of stained ceilings and remove the water damaged boxes and papers from the storage room in Central Services. Wall cuts maybe be appropriate to investigate if there are reservoirs of mold caused from past water intrusion, especially below the windows. Once the ceiling tiles are replaced, monitor the areas for re-occurring staining and repair the roof, if needed. Following intrusive assessment of the wall cavities around the windows, consider water testing the window assemblies and repair as necessary prior to repair of the wall assemblies.

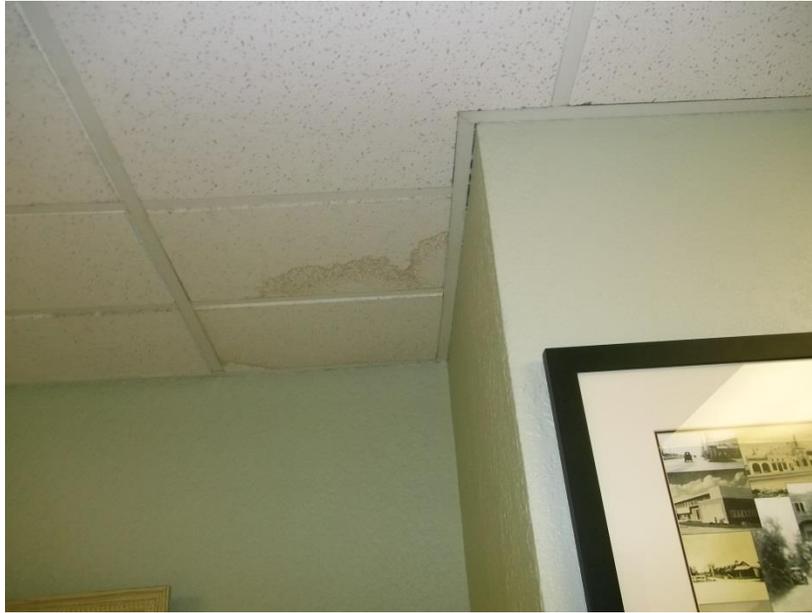
Photo 13: Stained ceiling tiles were observed at the water fountain.

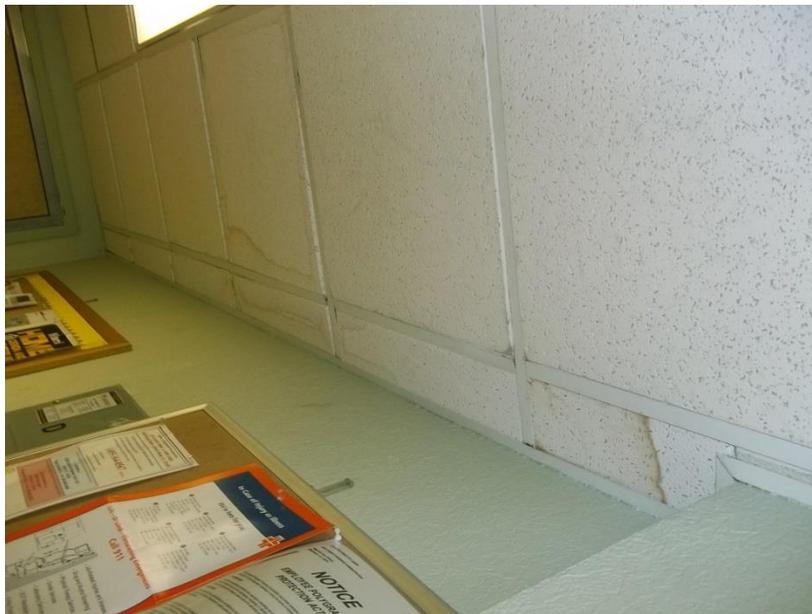
Photo 14: Stained ceiling tiles were observed at the Mezzanine.

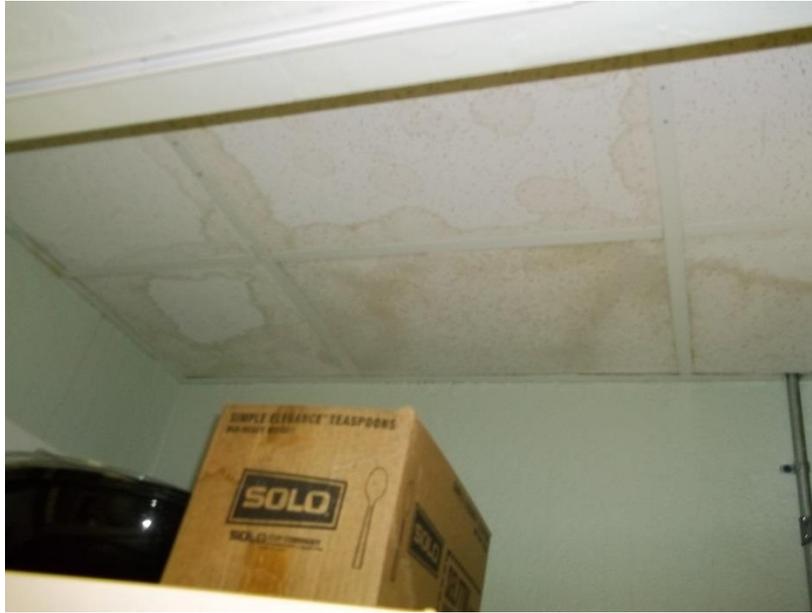
Photo 15: Stained ceiling tiles were observed at the Kitchenette.

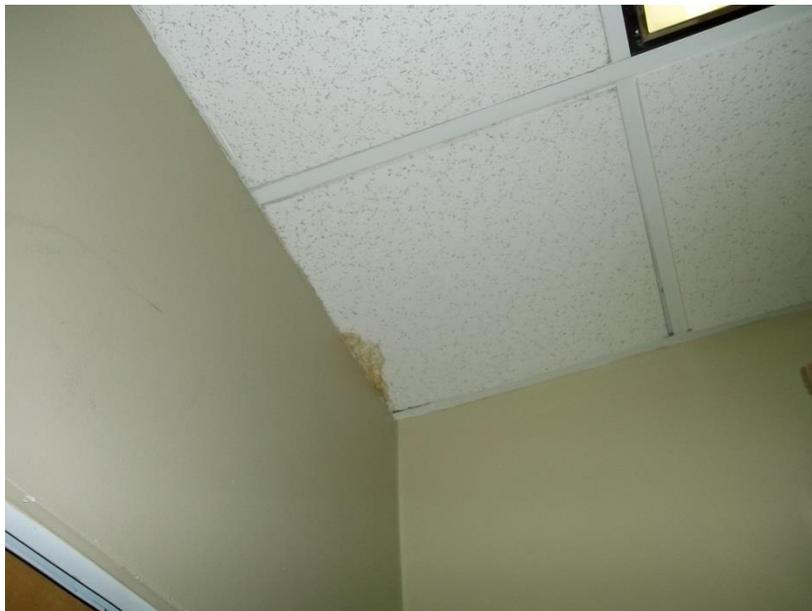
Photo 16: Stained ceiling tiles were observed in the Computer Room.

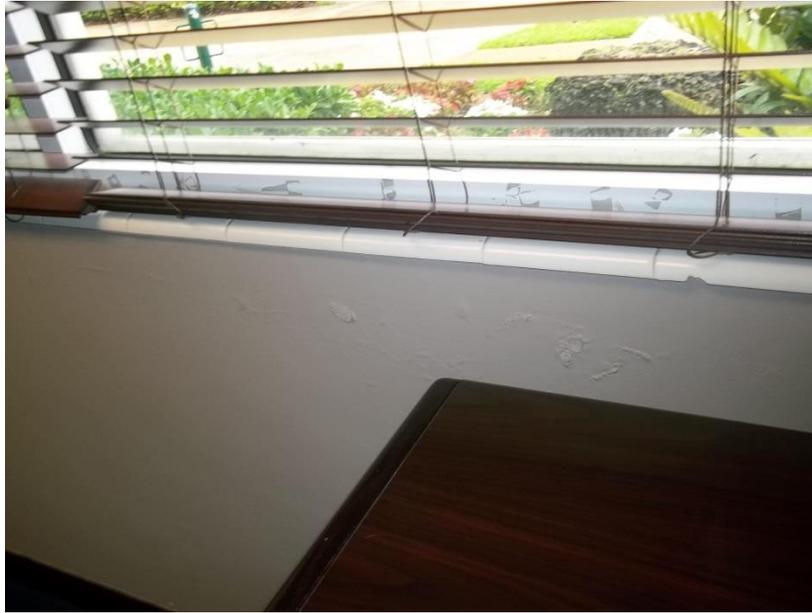
Photo 17: Damage to the plaster wall in the City Manager's Office.

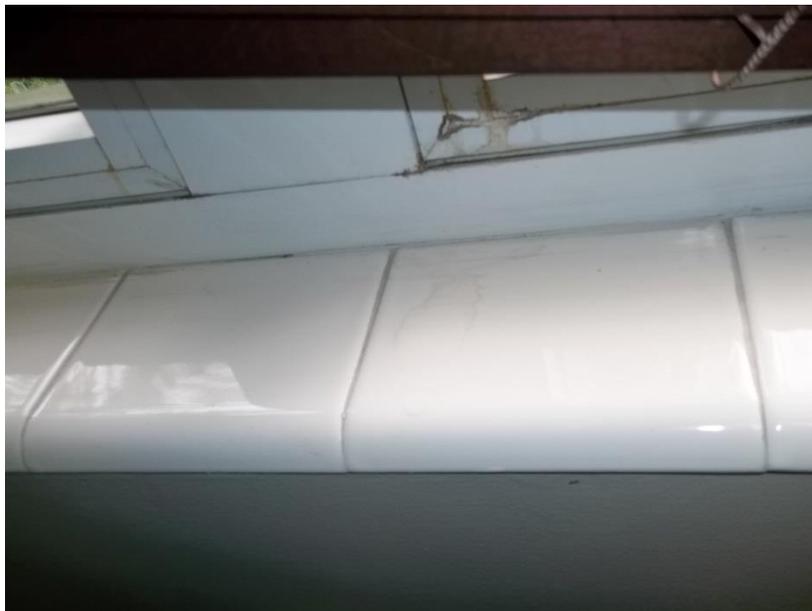
Photo 18: Stained window sill in the City Manager's Office.

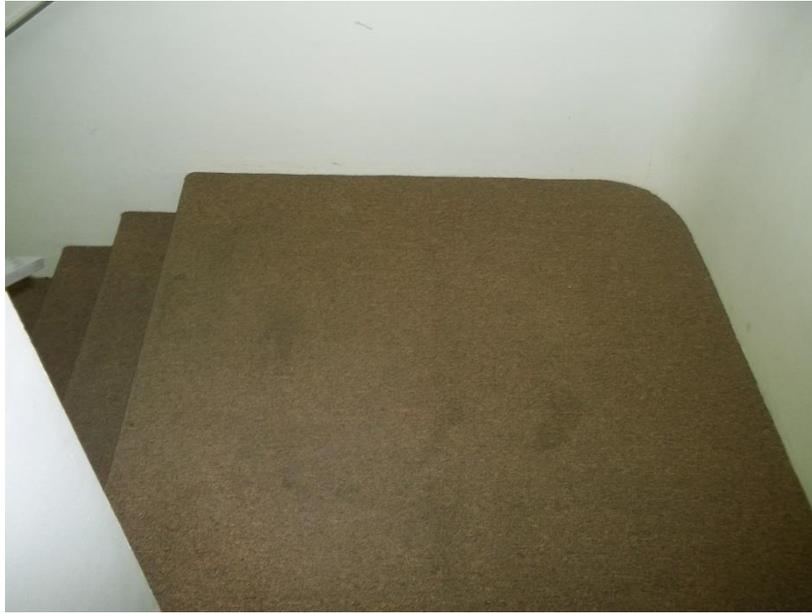
Photo 19: Water intrusion event on the landing on the stairs.

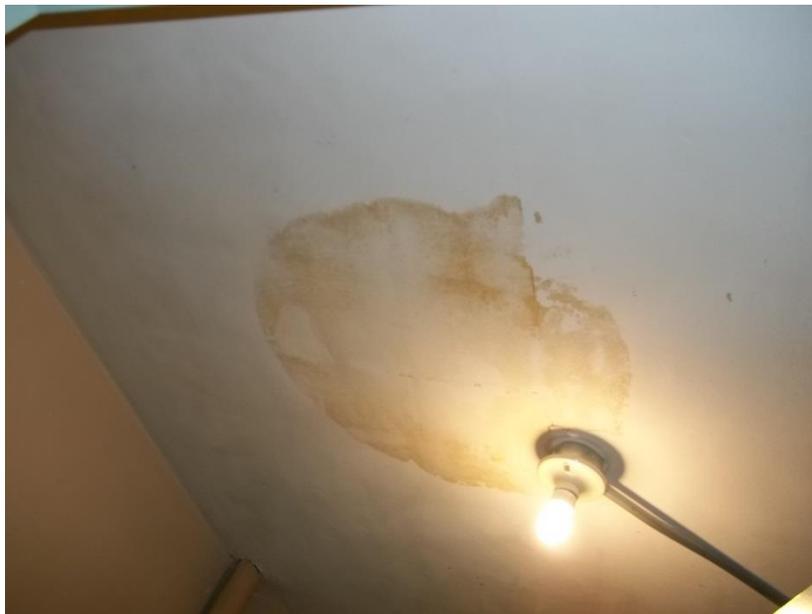
Photo 20: Water staining to the ceiling in the second floor storage closet.

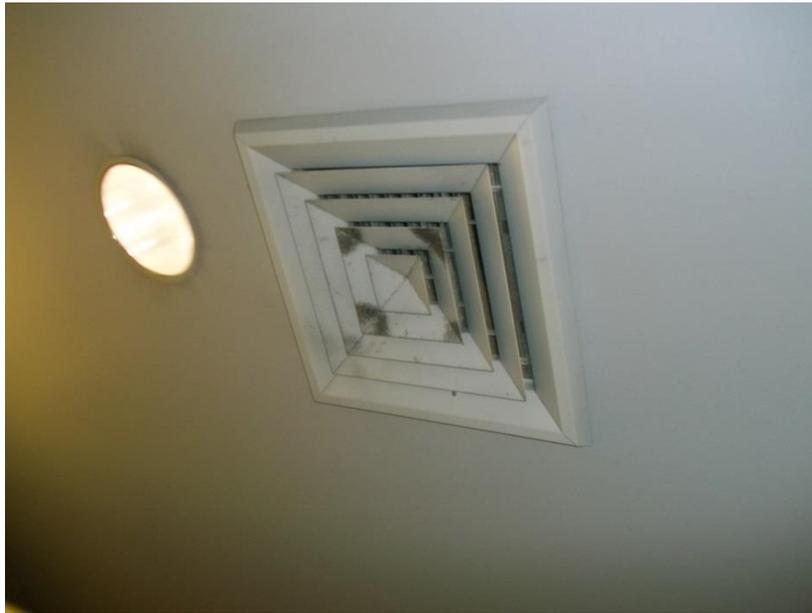
- There was DDD on the HVAC supply vents in various areas (see photo 21).
- Stained ceiling tiles were observed in the following areas:
 - North Stairwell (see photo 22)
 - Cubicles (see photo 23)
- Carpets were stained, dirty and generally worn.
- There was water dripping from the ceiling in Roll Call (see photo 24). It was assumed to be an HVAC leak and was being repaired during the assessment.
- Mosquitos were observed inside the building.

Photo 21: DDD on the HVAC vents in various areas.

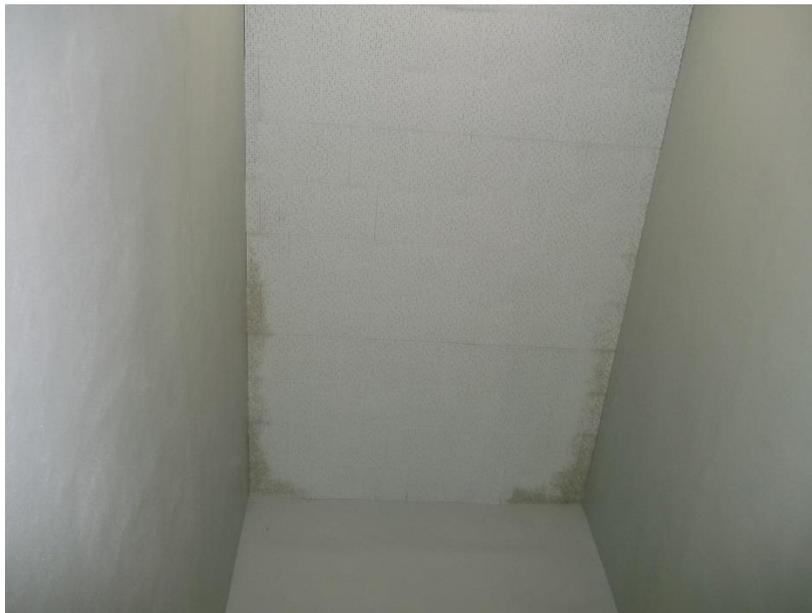
Photo 22: Stained ceiling tiles were observed in the North Stairwell.

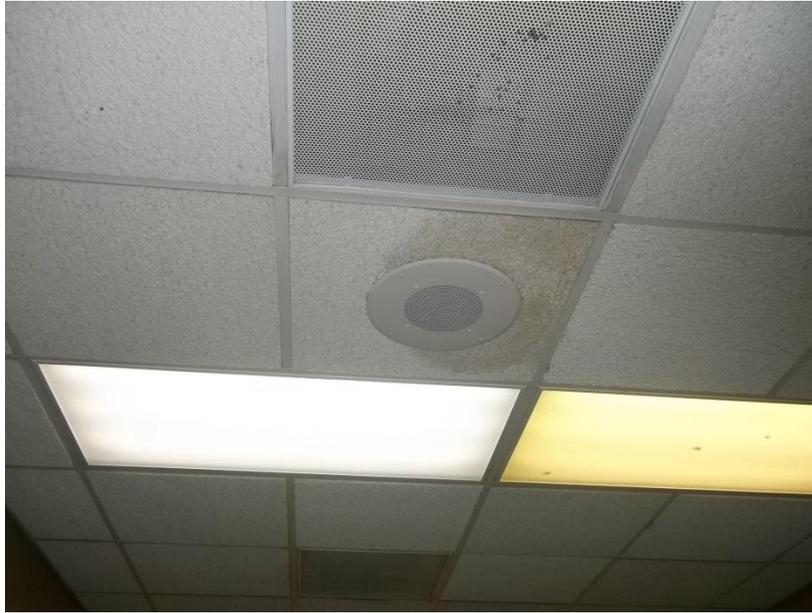
Photo 23: Stained ceiling tiles were observed in the Cubicles.

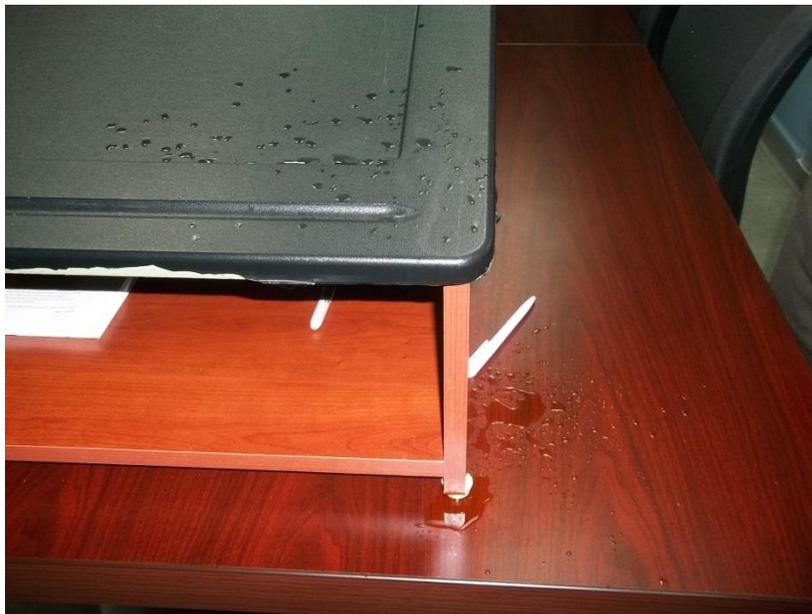
Photo 24: There was an active leak in Roll Call.

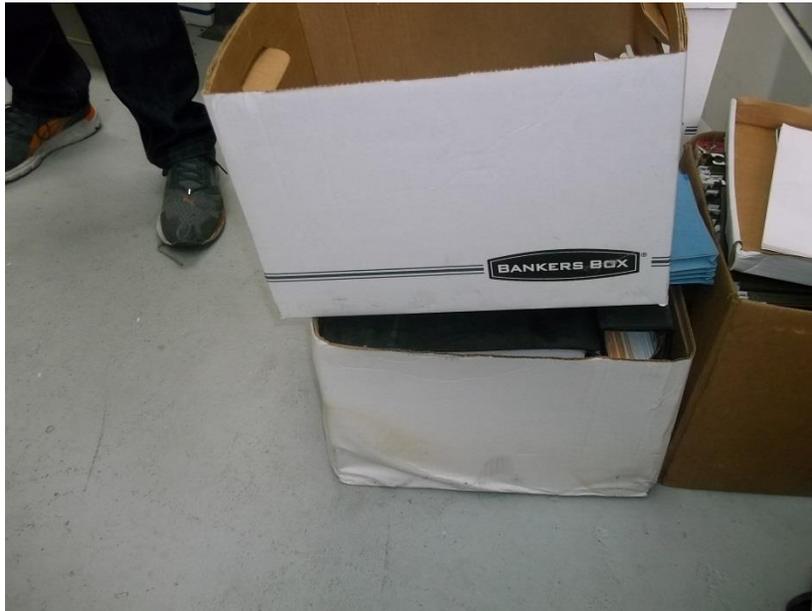
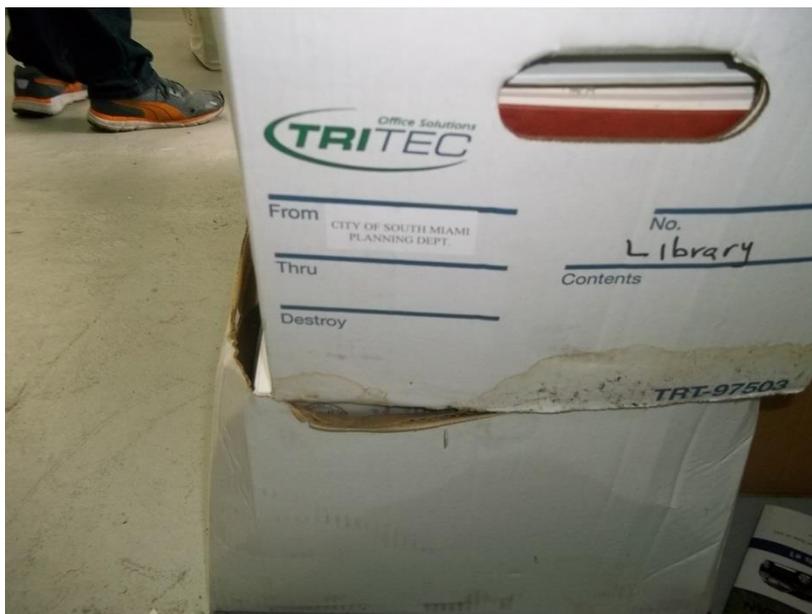
- The storage area had water damaged paperwork and boxes (see photos 25 and 26).
- The return air vent had DDD (see photo 27).
- There were stained ceiling tiles in the Women's Room (see photo 28).
- Mosquitos were prevalent inside the building.

Photo 25: The storage area had water damaged paperwork and boxes.

Photo 26: The storage area had water damaged paperwork and boxes.

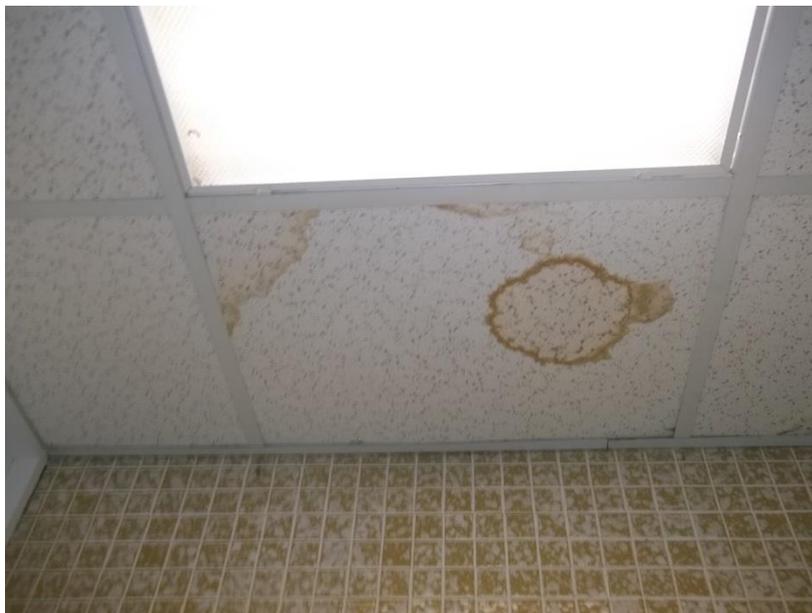
Photo 28: There were stained ceiling tiles in the Women's Room.
