# HEI Systems

## Report of Findings

**Assessment for a Malodorous Condition at a City Hall Building  
6130 Sunset Drive  
South Miami, Florida 33143  
File Number: 13-08-0101-M**

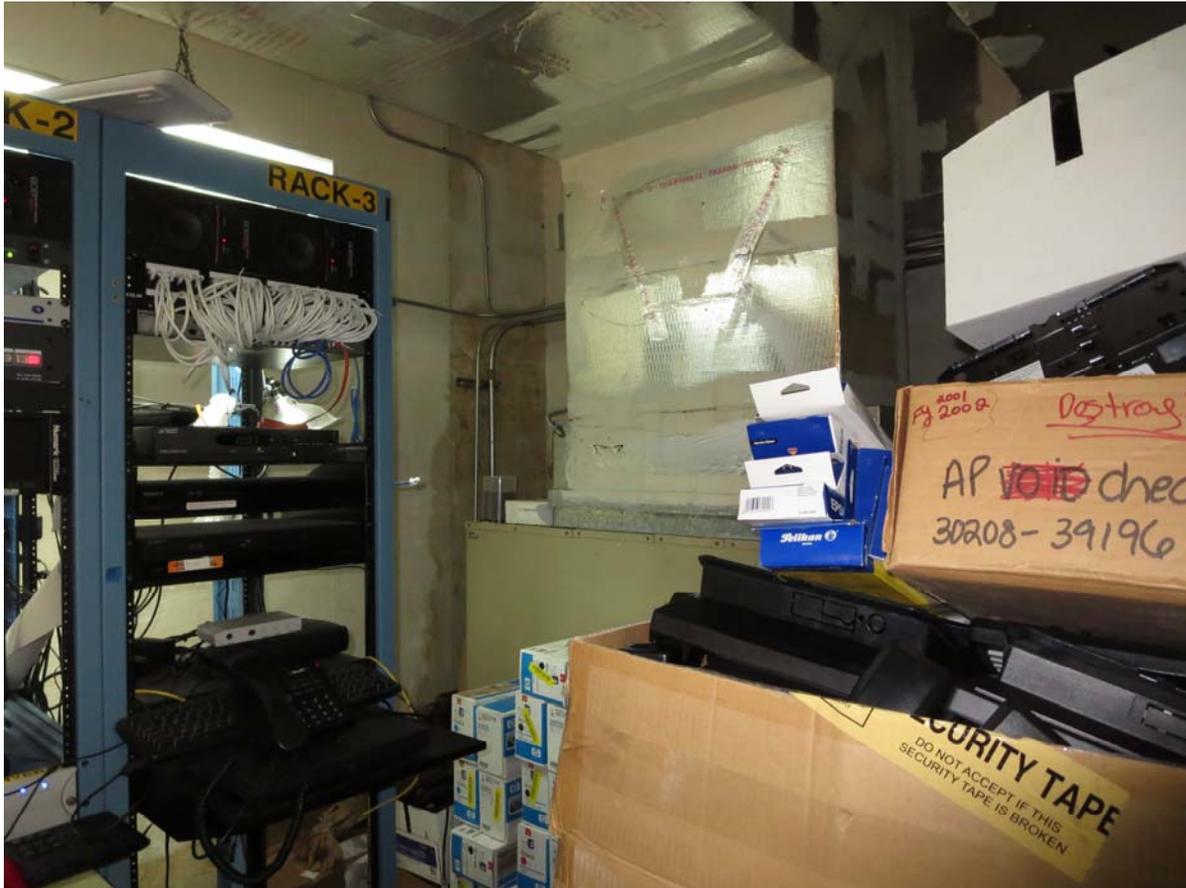
Location	Description	Photo #
HVAC Room	Prior water intrusion. Storage of paper and cardboard on floor.	2

Paper and cardboard boxes stored on the floor contribute to malodorous conditions. This condition was observed in the Manager's Conference Room, HVAC Room, the Human Resource Department and the Records Room. Banker Boxes and Cardboard storage should be placed upon shelving and plastic containers should be considered.

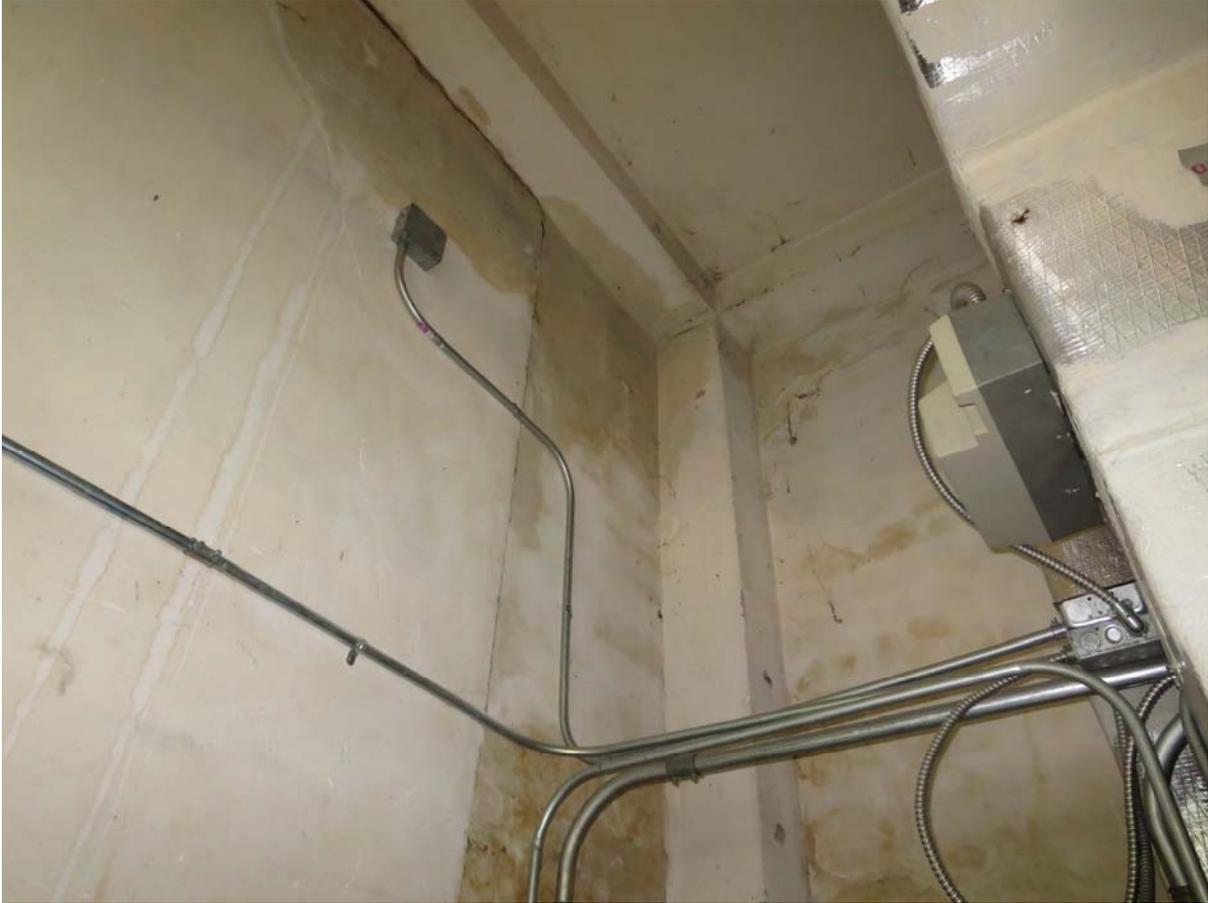
Location	Description	Photo #
<b>HVAC Room</b>	Prior water intrusion. Cracks in ceiling and walls should be sealed.	<b>3</b>

Unsealed concrete and cracking were observed in the HVAC Room in the walls and ceiling. All of the cracks should be sealed to prevent intrusion of water and outside air. Staining on the concrete at the wall bottoms and from the ceiling down is indicative of a history of water intrusion into the room.

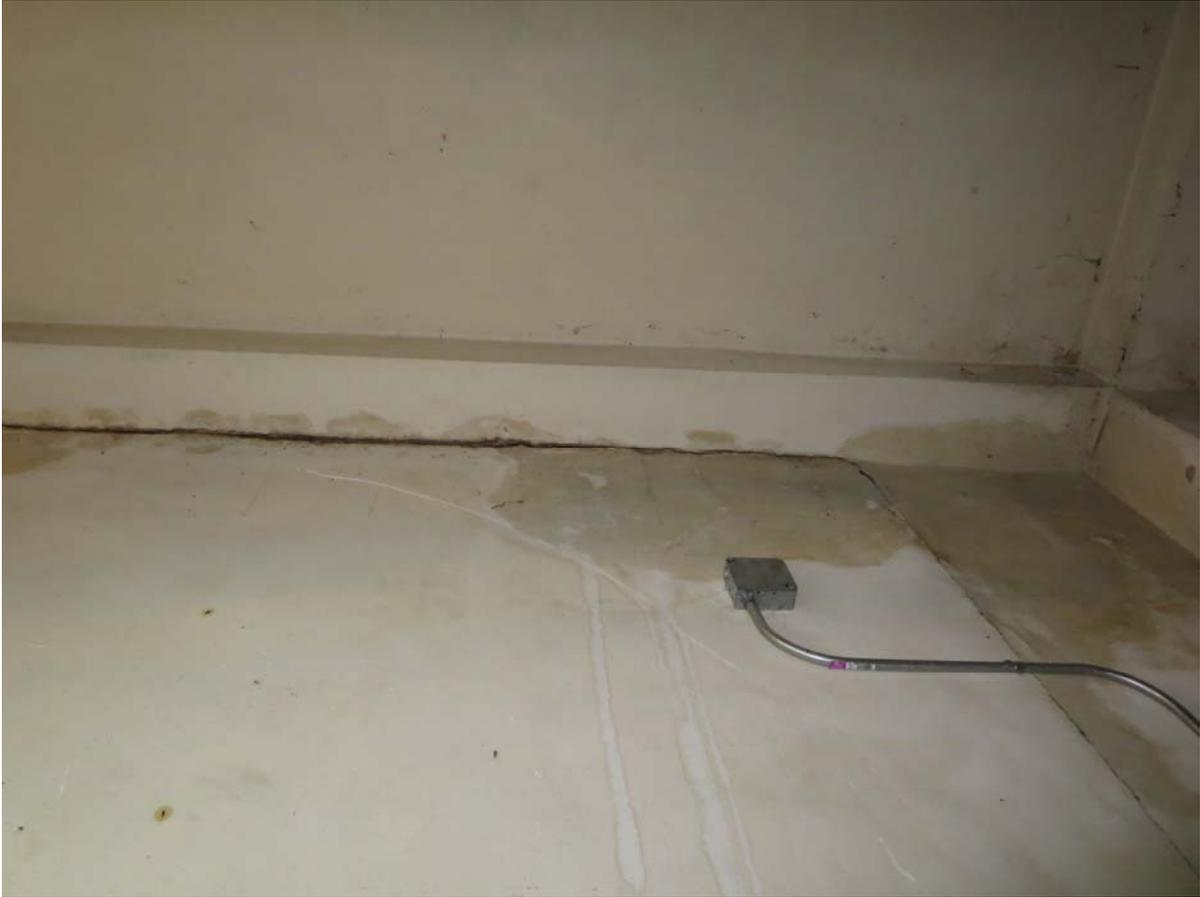
Location	Description	Photo #
<b>HVAC Room</b>	Cracks in ceiling at seam should be sealed to prevent moisture intrusion.	<b>4</b>

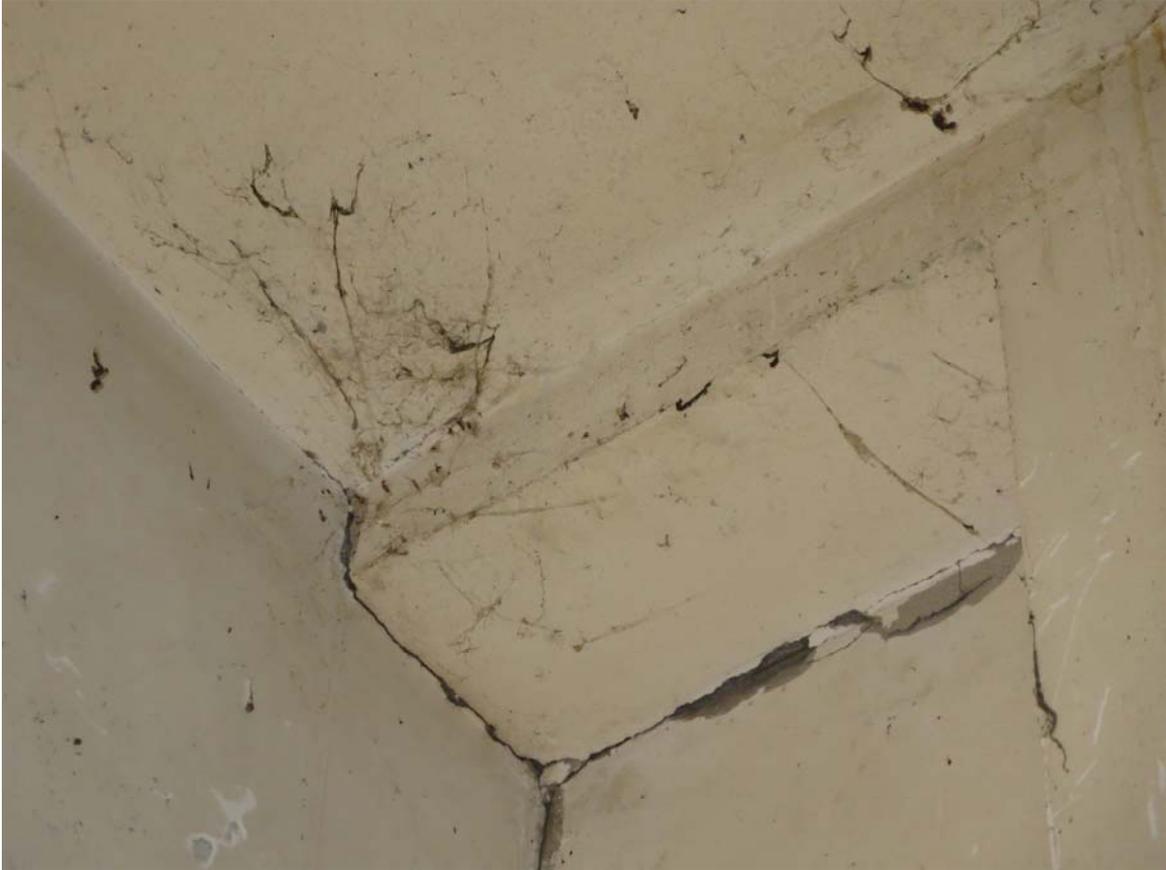
Location	Description	Photo #
HVAC Room	Concrete cracking in ceiling and walls.	5

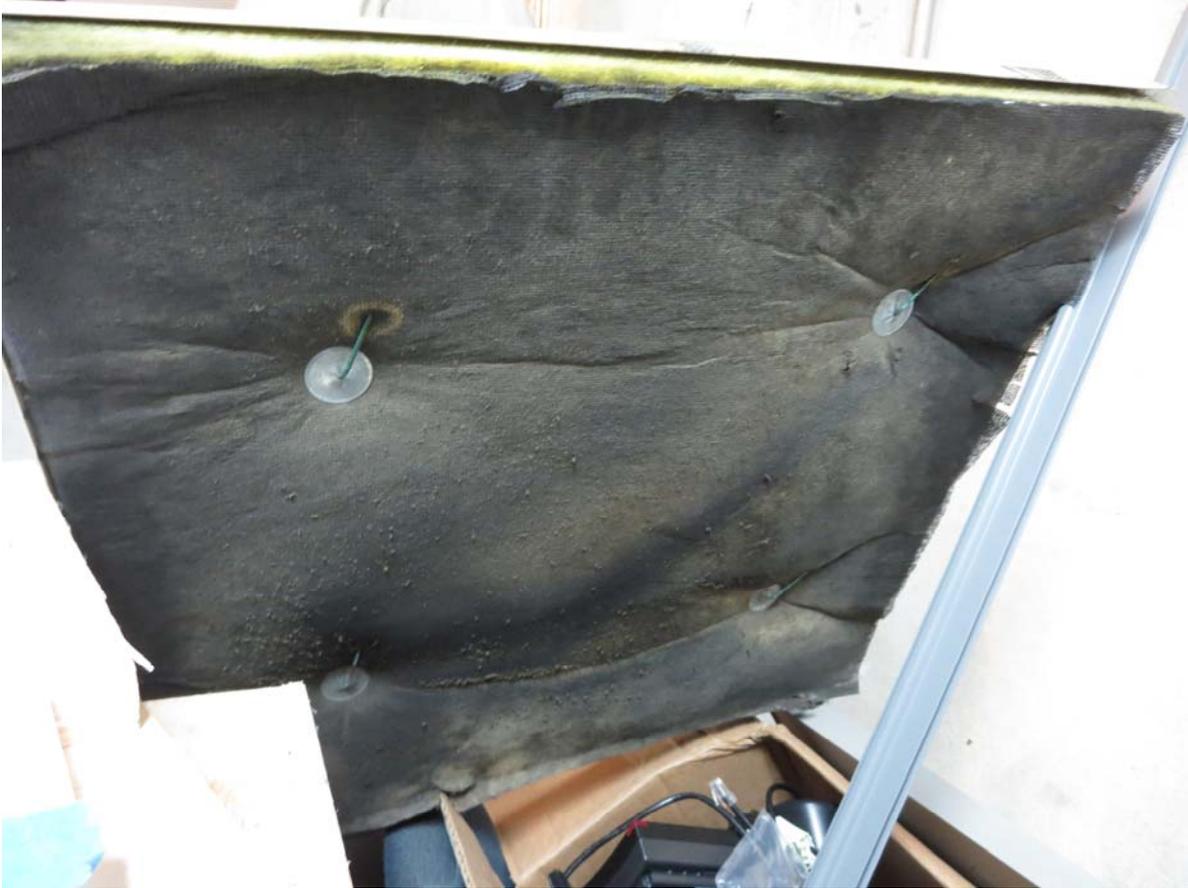
The interior component fiberglass insulation within the HVAC system air-handlers upstream of the filters was absorbed with dirt, debris, fungal growth (diffused into the fiberglass insulation) and allowing these particulate to be distributed throughout the building via the supply diffusers. Evidence of these particulate is seen on the covers and louvers of the supply diffusers throughout the building. The wall bottom of the Commission Chambers, the wall in the Mail Room outside of the Finance Department and the supply diffuser in the Women's Restroom adjacent to the Lobby are elevated in settled *Cladosporium* spore counts. Elevated *Cladosporium* counts associated with this

Location	Description	Photo #
<b>HVAC Room</b>	Air-Handler interior fiberglass lining impacted with fungal growth and undifferentiated debris. The fiberglass insulation should be replaced.	<b>6</b>

particular genus of fungal growth within HVAC systems are considered common. It is recommended that “time-release” activated charcoal be placed in the return plenums of the air-handlers to reduce odor throughout the building.

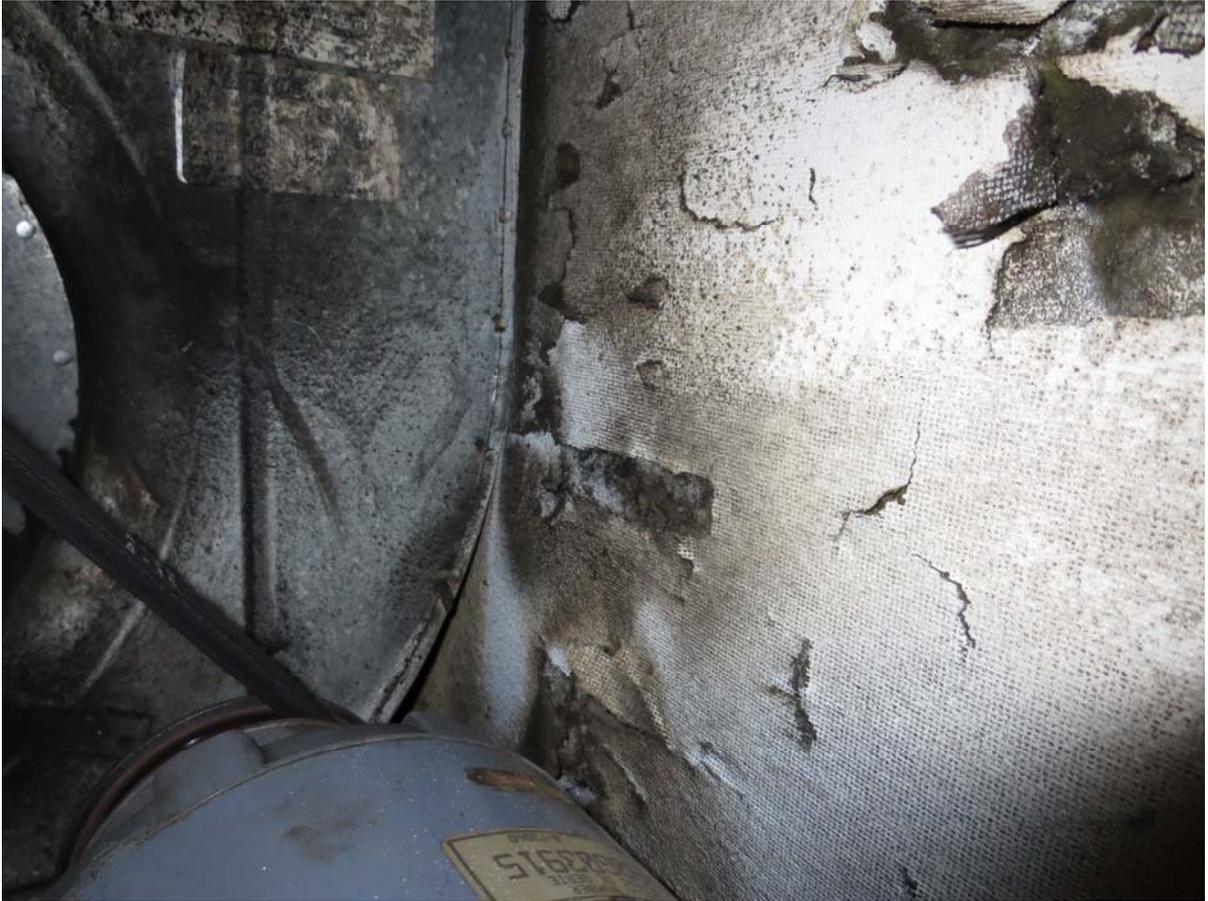
Location	Description	Photo #
<b>HVAC Room</b>	Air-Handler interior fiberglass lining impacted with fungal growth and undifferentiated debris. Insulation is torn and split open reducing its capacity to insulate. The fiberglass insulation should be replaced.	<b>7</b>

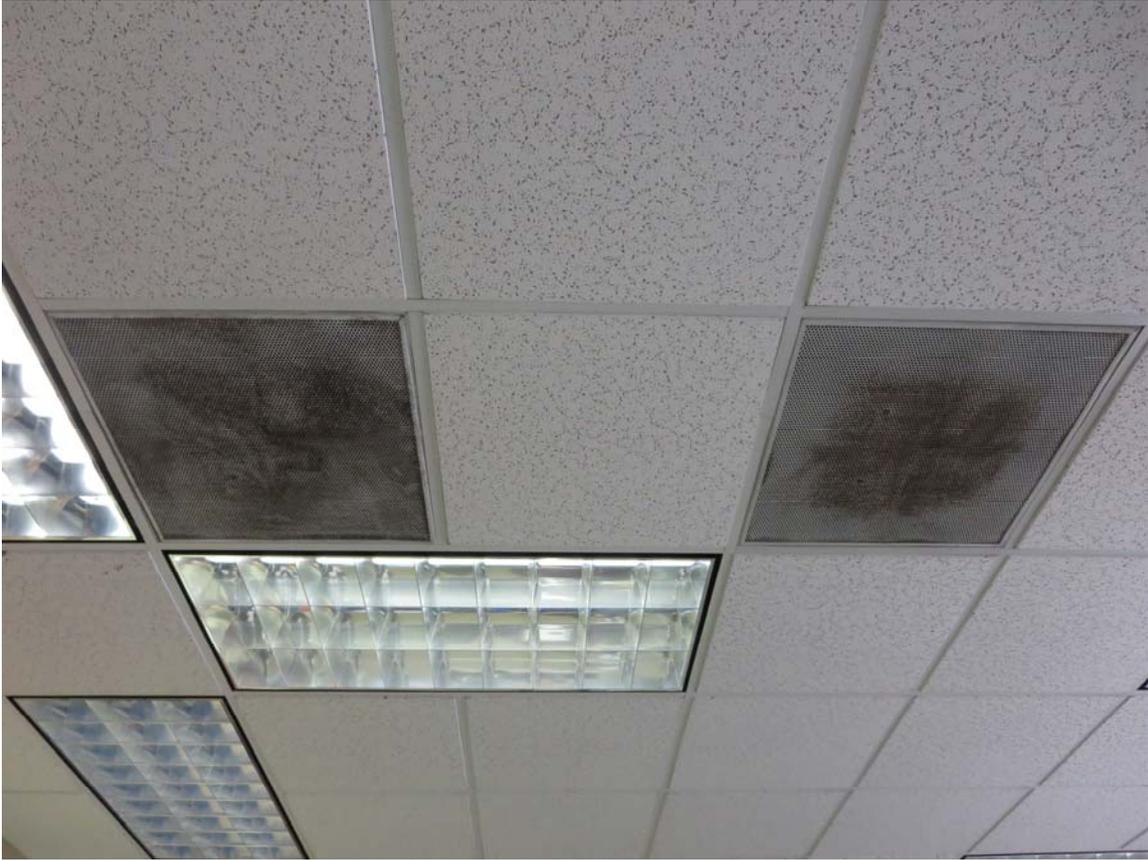
Location	Description	Photo #
<b>Finance Dept.</b>	Air conditioning supply diffusers impacted with debris and fungal growth and should be cleaned.	<b>8</b>

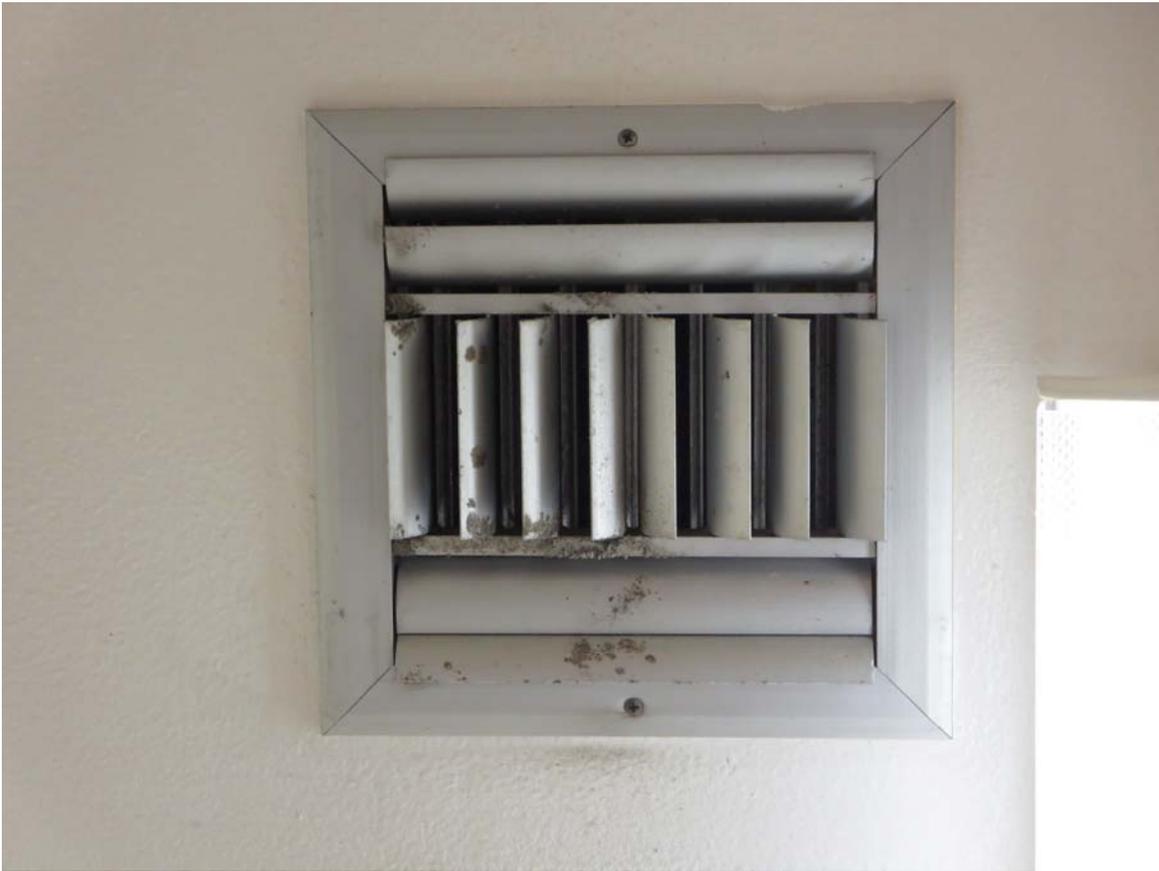
A direct sample was collected by sterile swab from the Lobby Women's Room supply diffuser, as a response to the suspect fungal growth on the surface. This sample was approximately 1 cm<sup>2</sup> in dimension. The results of this sample analysis by AEML, Inc. revealed the presence of 89,000 Cladosporium spores/cm<sup>2</sup>; 480 Ganoderma spores/cm<sup>2</sup> and 3,280 Hyphal Fragments/cm<sup>2</sup> in the sample collected.

Location	Description	Photo #
<b>Women's Room by Lobby</b>	Fungal growth and undifferentiated debris on supply diffuser. Diffuser should be cleaned.	<b>9</b>

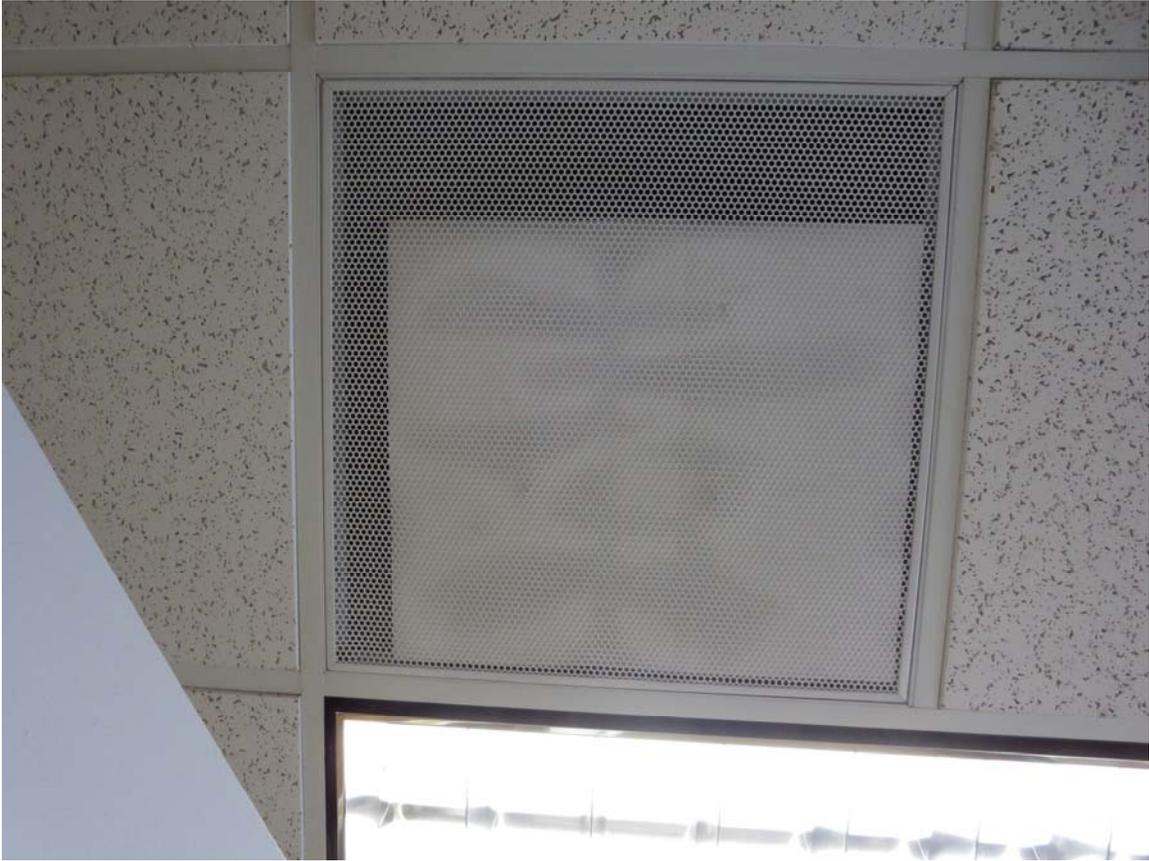
Location	Description	Photo #
<b>Human Resource Office</b>	Employee blocking the designed air-flow likely affects the proper balance of the HVAC system resulting in thermal comfort issues.	<b>10</b>

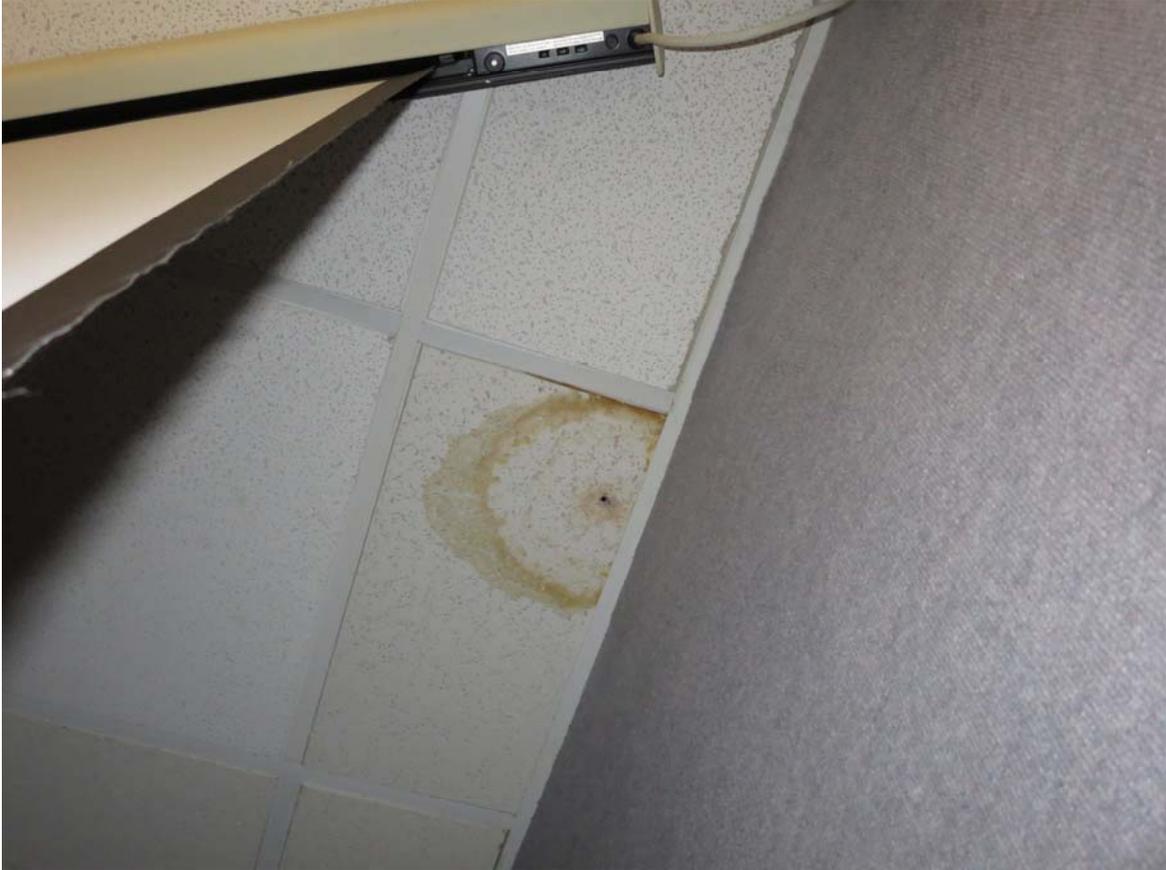
Location	Description	Photo #
Commission Chambers	Water staining and fungal growth in ceiling tiles. Tiles should be replaced and in-line tracks should be cleaned.	11

Stained ceiling tiles should be removed and discarded as they are repositories for fungal growth and malodorous conditions. The source of the staining should be defined and repaired. Stained ceiling tiles were noted in the Commission Chambers Room.

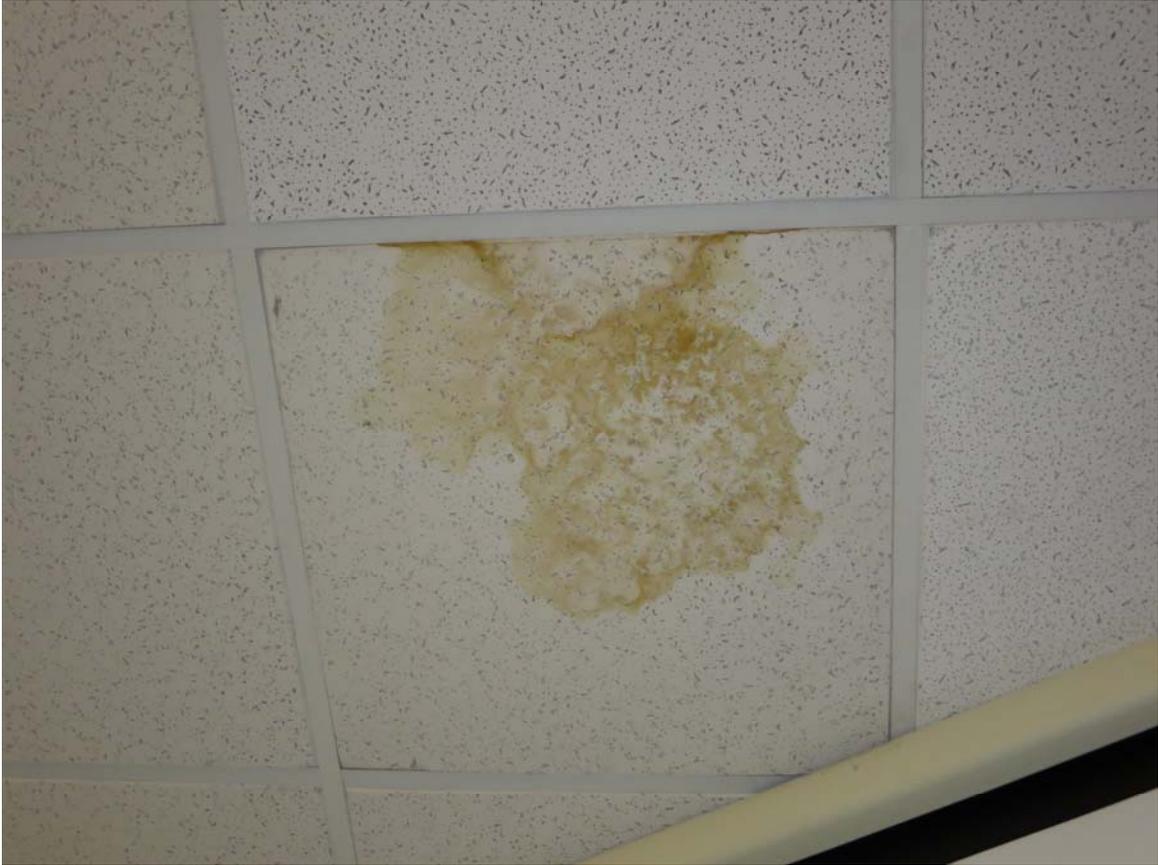
<b>Location</b>	<b>Description</b>	<b>Photo #</b>
<b>Commission Chambers</b>	Water staining and fungal growth in ceiling tiles. Tiles should be replaced and in-line tracks should be cleaned.	<b>12</b>

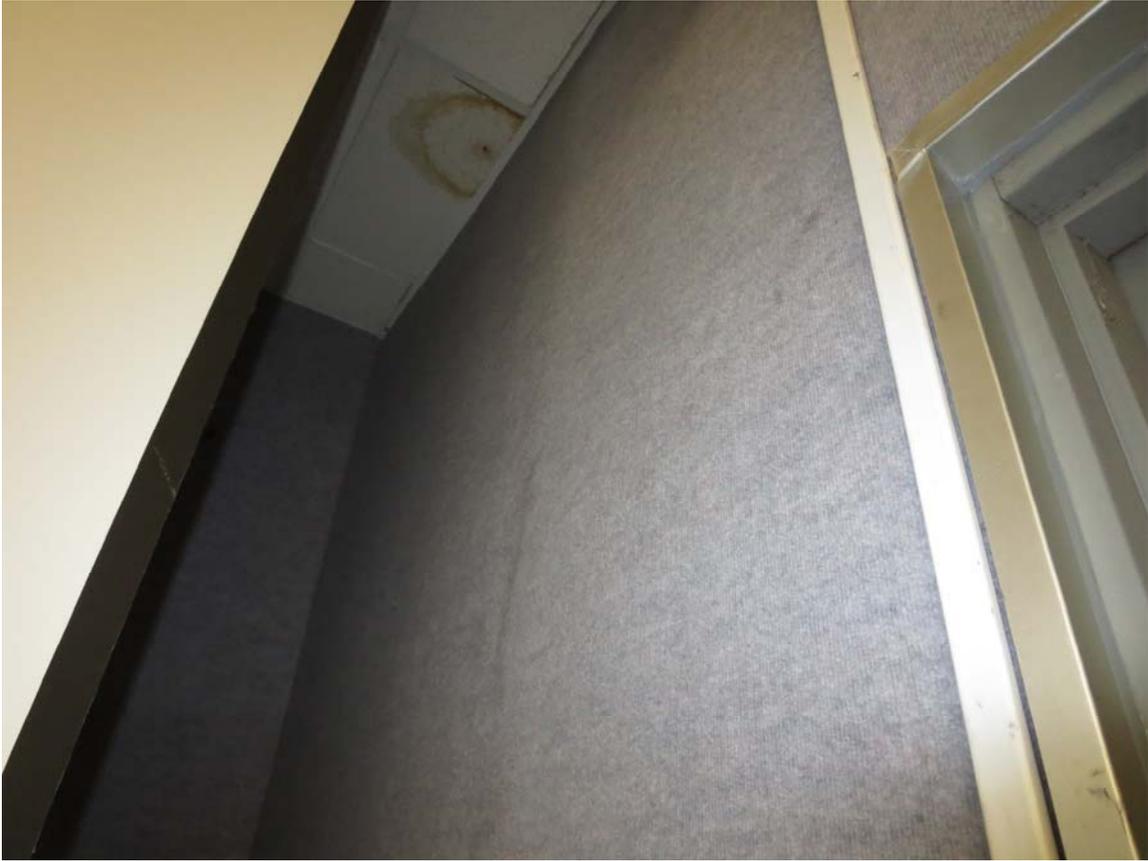
Location	Description	Photo #
<b>Commission Chambers</b>	Water staining from intrusion on ceiling tile and behind carpeting used for soundproofing. Carpeting is splitting and malodorous.	<b>13</b>

The vertical carpet soundproofing at the front of the Commission Chambers Room is malodorous, water damaged and separating at some seams. The exposed glue on the back side of the carpet presents with suspect fungal growth. This carpeting should be removed and discarded, and the remaining glues abrasively removed from the wall and the wall sealed.

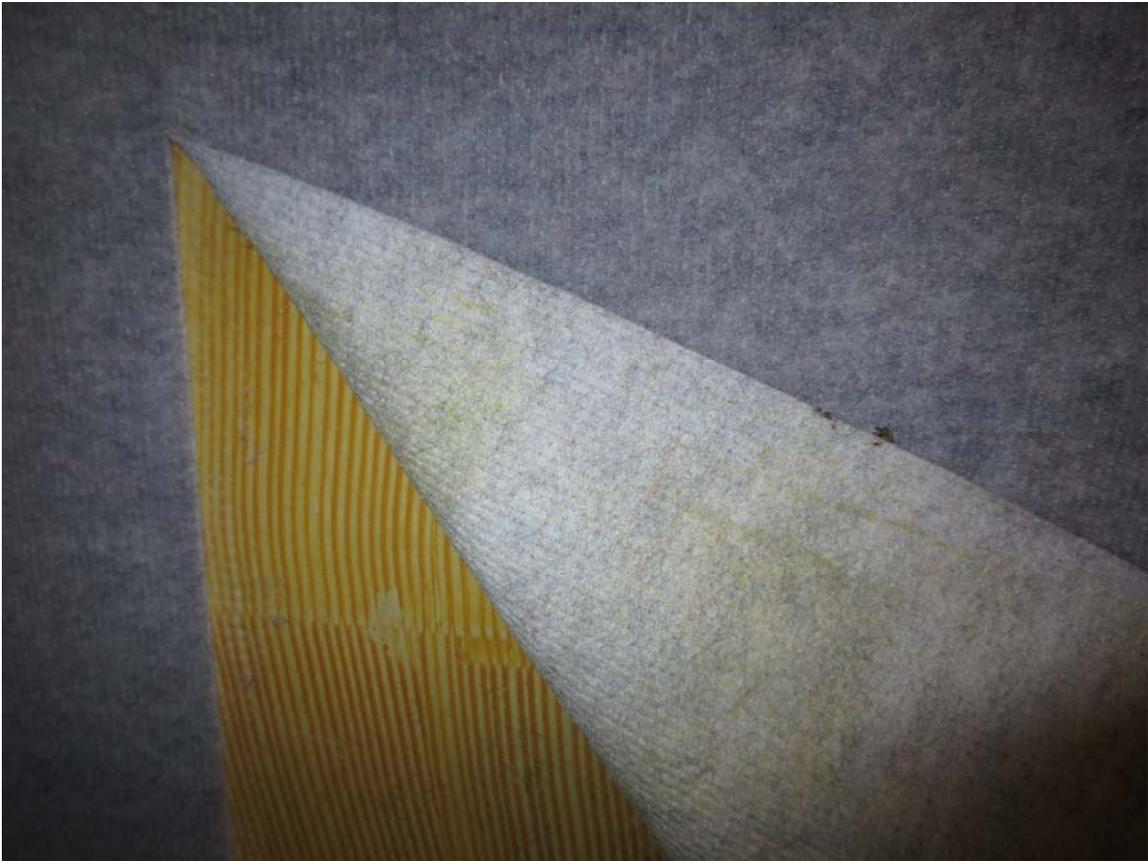
Location	Description	Photo #
<b>Commission Chambers</b>	Water staining from intrusion on ceiling tile and behind carpeting used for soundproofing. Carpeting is splitting and malodorous. Fungal growth on back side of carpeting. Glue is source of nutrition for fungal growth.	<b>14</b>

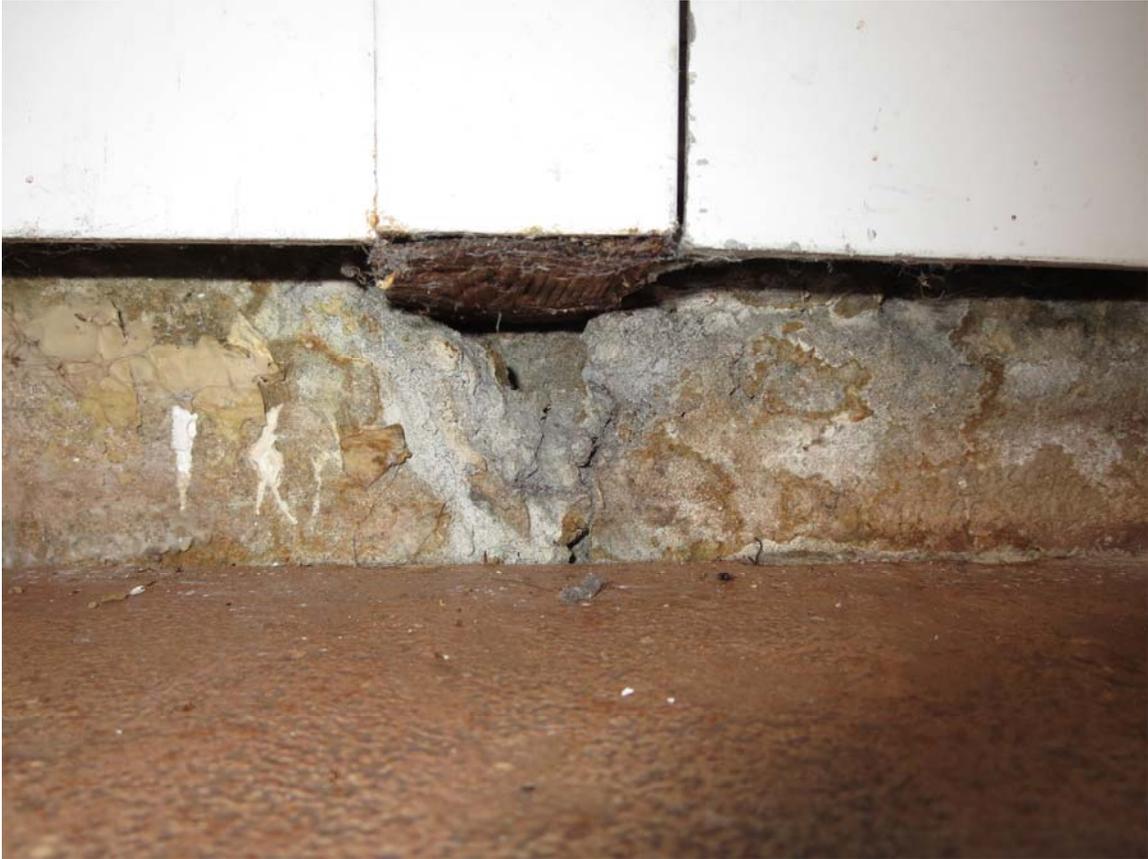
A direct sample was collected by sterile swab from the Commission Chambers wall bottom beneath the exterior windows, as a response to the moisture intrusion, and suspect fungal growth on the surface. This sample was approximately 1 cm<sup>2</sup> in dimension. The results of this sample analysis by AEML, Inc. revealed the presence of 7,120 Aspergillus/Penicillium-like spores/cm<sup>2</sup> 10,800 Cladosporium spores/cm<sup>2</sup> and 880 Hyphal Fragments/cm<sup>2</sup> in the sample collected.

<b>Location</b>	<b>Description</b>	<b>Photo #</b>
<b>Commission Chambers</b>	Intrusion of moisture, and warm humid air from exterior beneath windows in Chambers. Pathway for insects and reptiles tracking water from outside.	<b>15</b>

Intrusions of warm, humid air through the building envelop should be sealed to prevent any further intrusion and subsequent condensation, water intrusion and damage, corrosion, staining and fungal growth. Intrusions of warm, humid air were found in the Commission Chambers beneath the exterior windows and the exterior metal door leading out to the generator. The area beneath the windows is allowing moisture and insects to enter the room. The door is corroded and daylight can be observed on both sides of the door when the door is fully closed at the bottom. Weather stripping and sealing are recommended for this door.

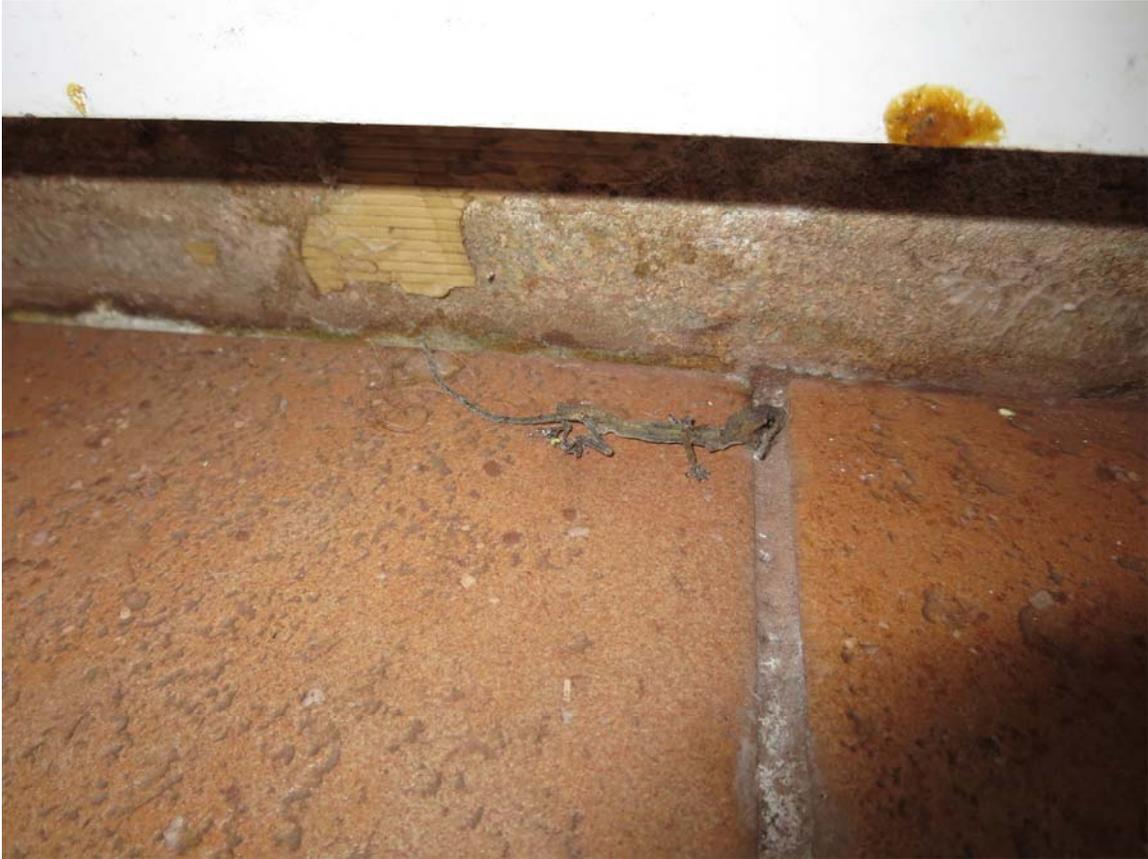
A direct sample was collected by sterile swab from the Commission Chambers window frame, as a response to the moisture intrusion, and suspect fungal growth on the surface. This sample was approximately 1 cm<sup>2</sup> in dimension. The results of this sample analysis by AEML, Inc. revealed the presence of 80 Cladosporium spores/cm<sup>2</sup> and 80 Curvularia spores/cm<sup>2</sup> in the sample collected.

Location	Description	Photo #
<b>Commission Chambers</b>	Intrusion of moisture, and warm humid air from exterior beneath windows in Chambers. Pathway for insects and reptiles tracking water from outside. Prior water damage.	<b>16</b>

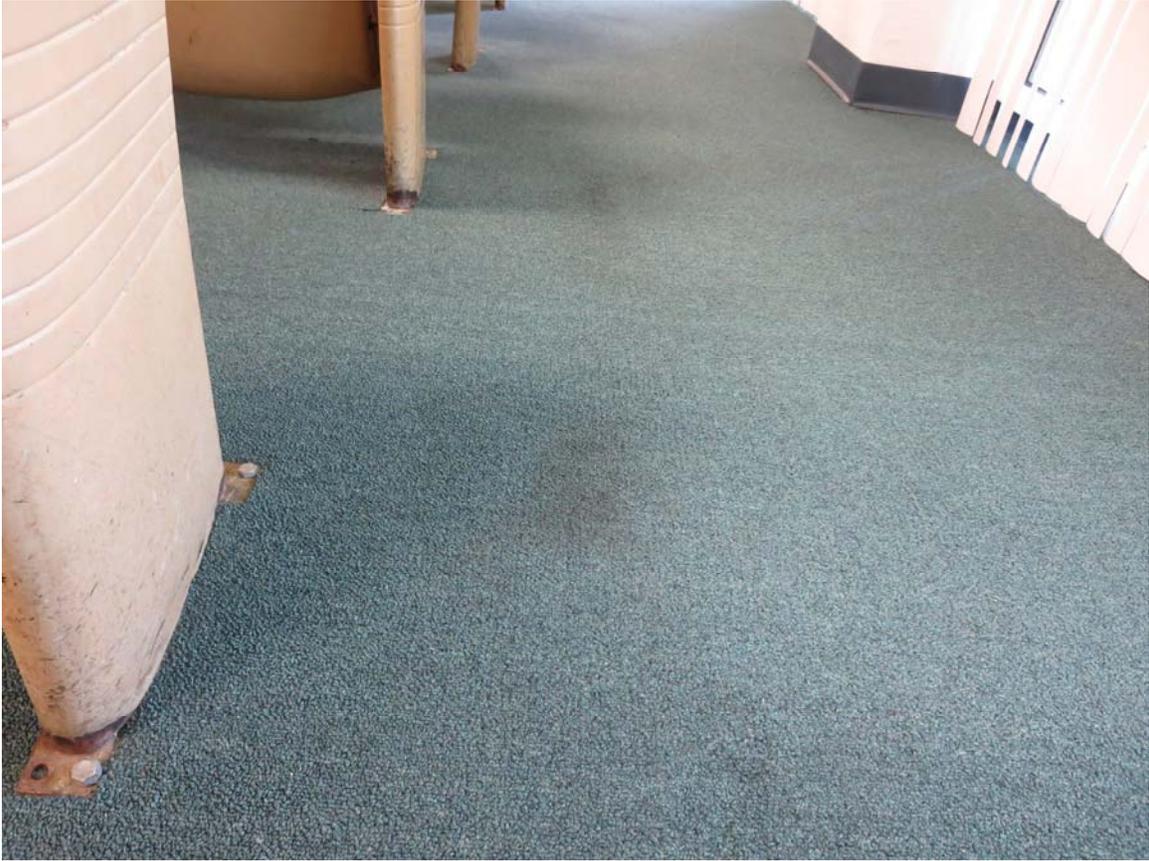
An interpretation of the laboratory analysis of the 5 liter aerosol sample collected from the Commission Chamber's carpet results in the rejection of the null hypothesis, and a finding that this carpet substrate may be considered to be in a state of elevated fiber, fungi and particulate.

Location	Description	Photo #
<b>Commission Chambers</b>	Worn, stained, splitting and malodorous carpeting throughout the Chambers should be removed and concrete slab sealed prior to installation of any new floor covering.	<b>17</b>

The carpeting throughout the building is old, damaged, stained, odorous, and at the end of its normal lifespan or beyond. The carpet is replete with excessive and undifferentiated debris, insect and lizard parts, skin cells, fiberglass, and fungal spores that are no longer removable by normal maintenance and cleaning. The carpeting is beyond normal cleaning and should be removed and discarded throughout the building. The concrete slab beneath the carpeting should be abrasively cleaned and sealed, prior to

the installation of any new floor covering. Carpeting, as a new floor covering would not be recommended, rather, some form of hard surface floor covering. Should the carpeting be found to be installed upon vinyl composition tile or linoleum, then the vinyl sub-surface should be removed and discarded to the slab, and then the slab abrasively cleaned and sealed prior to the installation of any new floor covering. Vinyl composition and linoleum surfaces are usually the most difficult to decontaminate as they have a tendency to adsorb and hold odors for a long period of time.

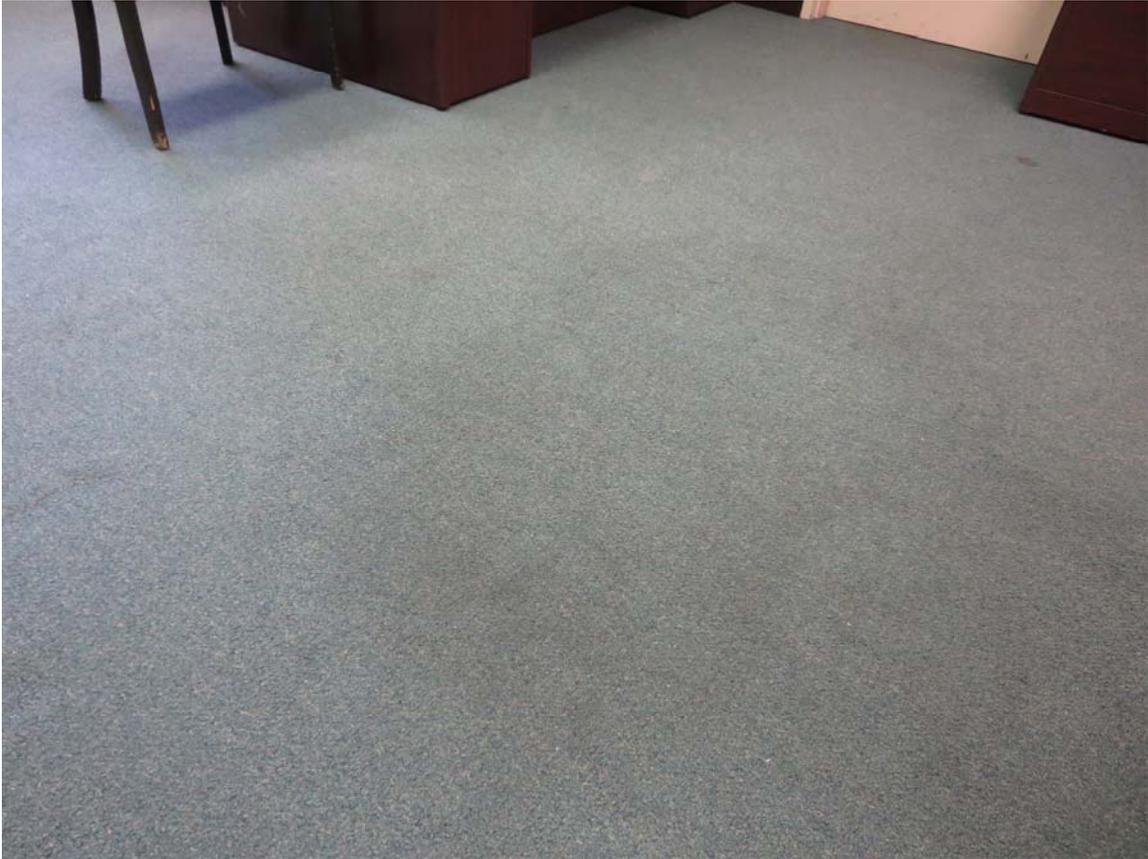
<b>Location</b>	<b>Description</b>	<b>Photo #</b>
<b>Executive Assistant Office</b>	Worn, stained and malodorous carpeting throughout all of the 1 <sup>st</sup> Floor Offices should be removed and concrete slab sealed prior to installation of any new floor covering.	<b>19</b>

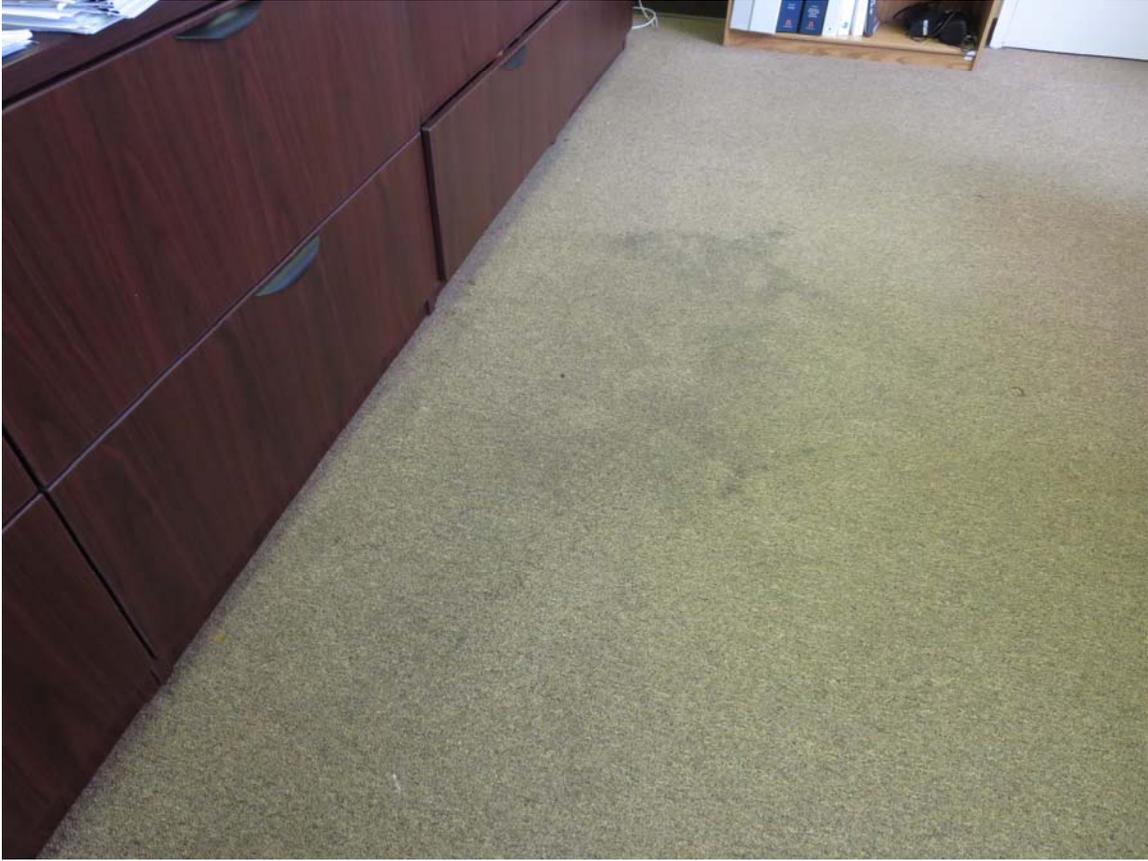
Location	Description	Photo #
<b>Human Resources Office</b>	Worn, stained and malodorous carpeting throughout all of the 2 <sup>nd</sup> Floor Offices should be removed and concrete slab sealed prior to installation of any new floor covering.	<b>20</b>

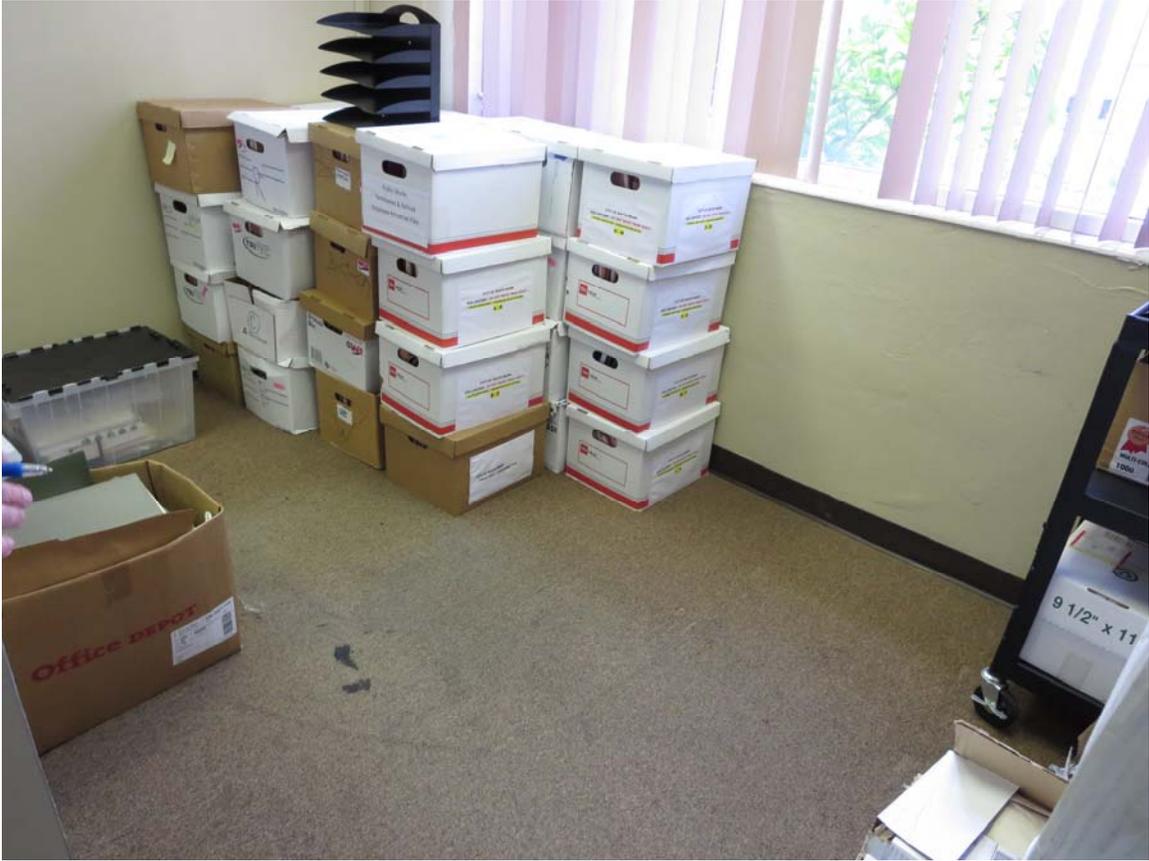
Location	Description	Photo #
<b>Human Resource Office</b>	Worn, stained and malodorous carpeting and storage of cardboard and paper on floor.	<b>21</b>

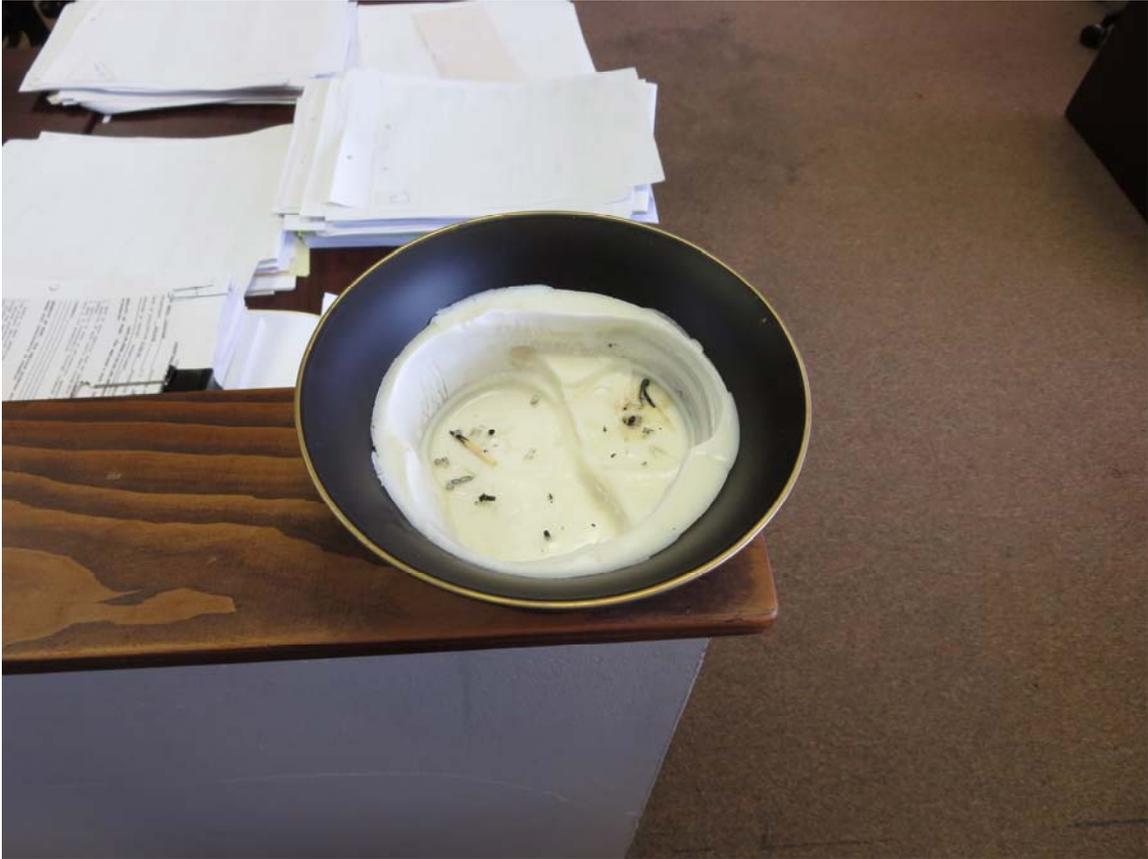
Location	Description	Photo #
<b>Human Resource Office</b>	Use of fragrance candles and plug-in deodorizers to mask odors in office space should be discouraged. Placement of time-release activated charcoal in return plenums of air-handlers should help reduce odors.	<b>22</b>
