# HEI Systems

## Report of Findings

**Assessment for a Malodorous Condition at a City Hall Building  
6130 Sunset Drive  
South Miami, Florida 33143  
File Number: 13-08-0101-M**

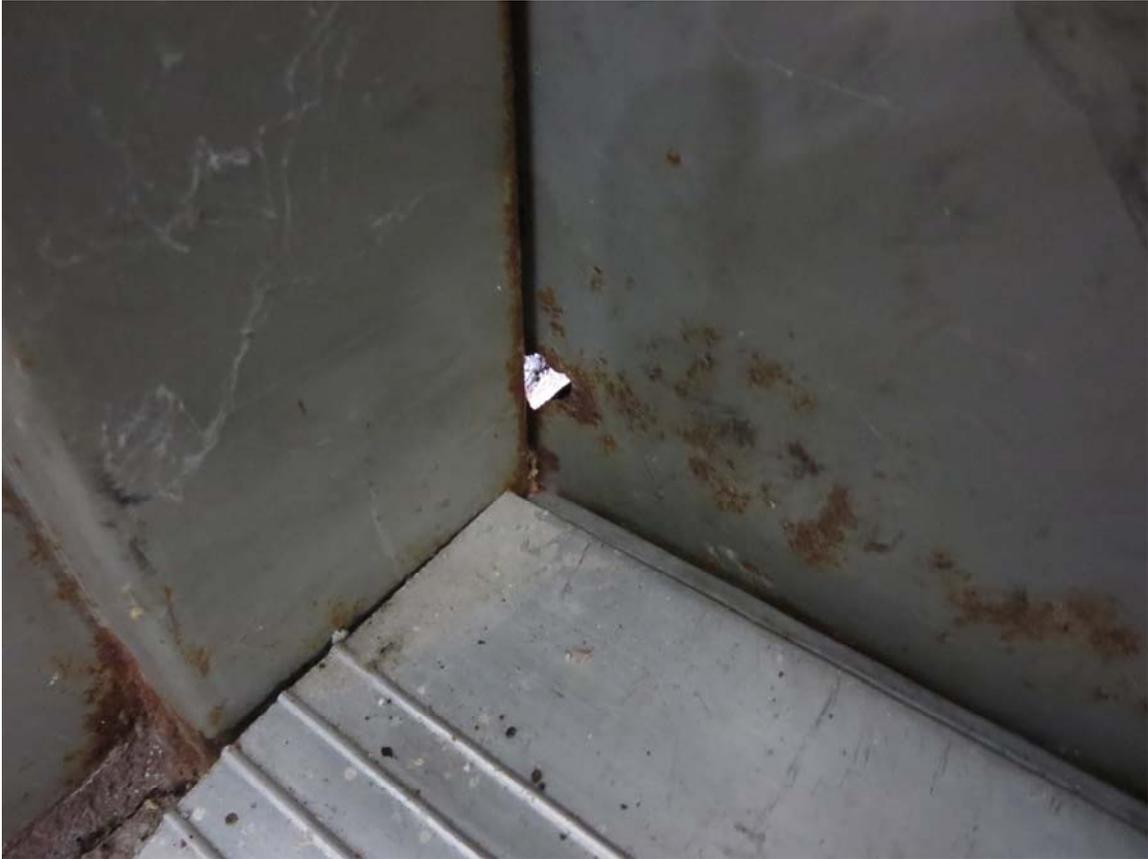
Location	Description	Photo #
<b>Commission Chambers</b>	Corrosion and opening to outside allows warm humid air into Chambers from exterior door leading to generator. Weather stripping on door bottom and sealing holes recommended.	<b>23</b>

Intrusions of warm, humid air through the building envelop should be sealed to prevent any further intrusion and subsequent condensation, water intrusion and damage, corrosion, staining and fungal growth. Intrusions of warm, humid air were found in the Commission Chambers beneath the exterior windows and the exterior metal door leading out to the generator. The area beneath the windows is allowing moisture and insects to enter the room. The door is corroded and daylight can be observed on both sides of the door when the door is fully closed at the bottom. Weather stripping and sealing are recommended for this door.

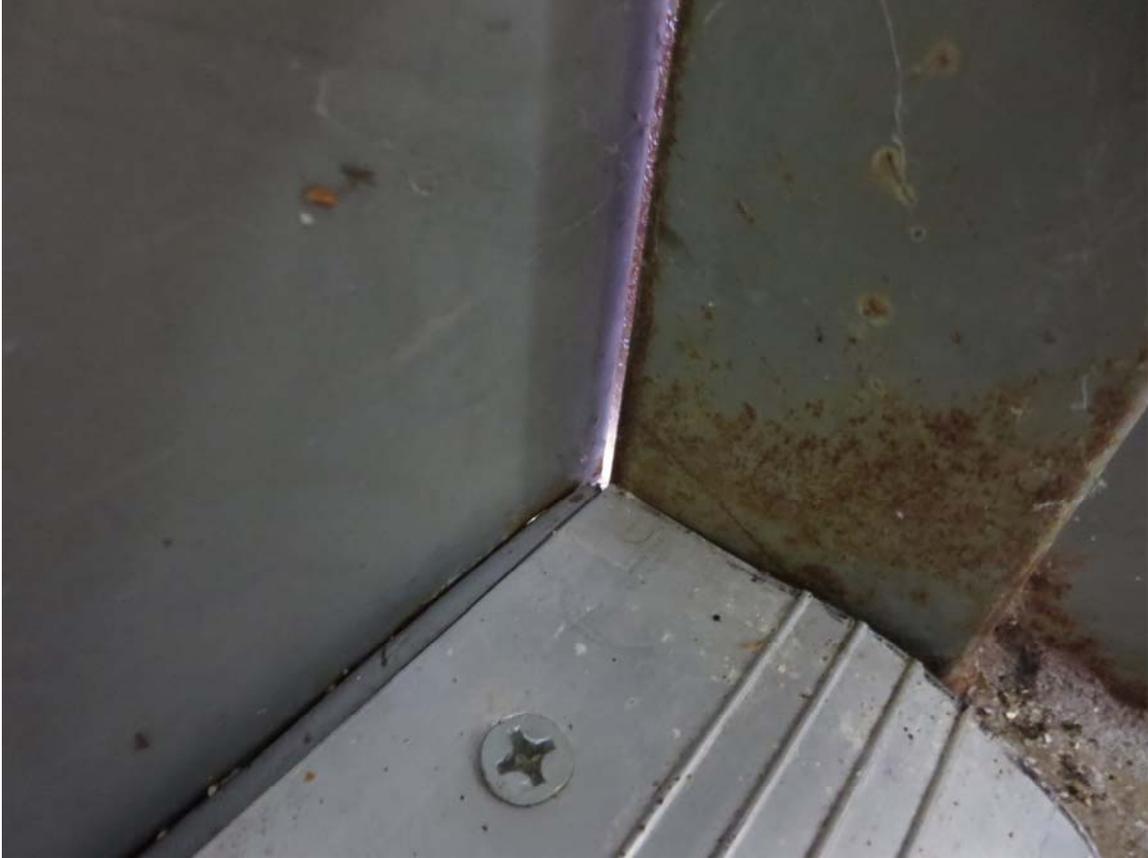
Location	Description	Photo #
<b>Commission Chambers</b>	Corrosion and opening to outside allows warm humid air into Chambers from exterior door leading to generator. Weather stripping on door bottom and sealing holes recommended.	<b>24</b>

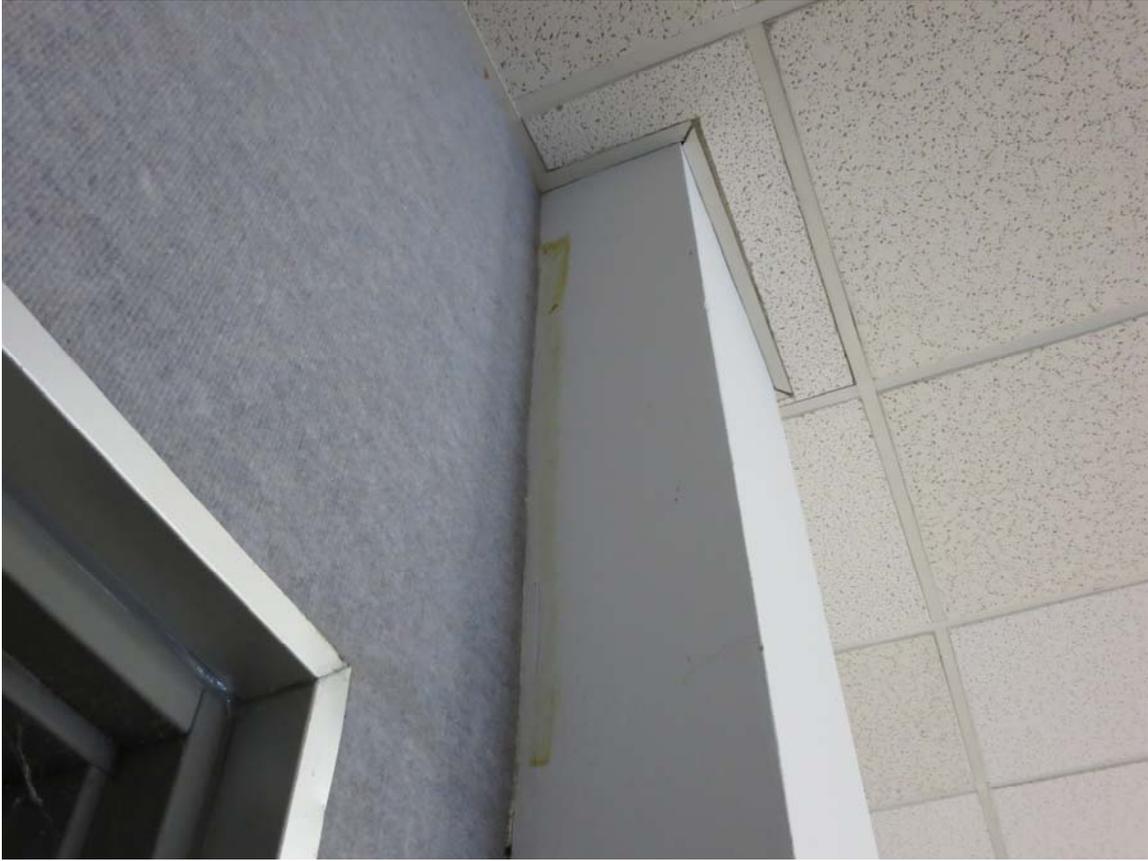
<b>Location</b>	<b>Description</b>	<b>Photo #</b>
<b>Commission Chambers</b>	Intrusion above ceiling tiles running down wall on column and beneath carpet soundproofing.	<b>25</b>
